INSPECTION REPORT PART (IRP)

INSPECTION NO FOR CLIENT REFERENCE:	IRP-GL-091018
PRODUCT NAME:	Driving Gloves.
PO NUMBER:	xxxxxx
INSPECTION DATE:	09 Oct 2018
INSPECTION LOCATION:	Kolkata
INSPECTOR NAME:	Sunny Khan
FACTORY DETAILS:	ISP
CUSTOMER NAME :	EP

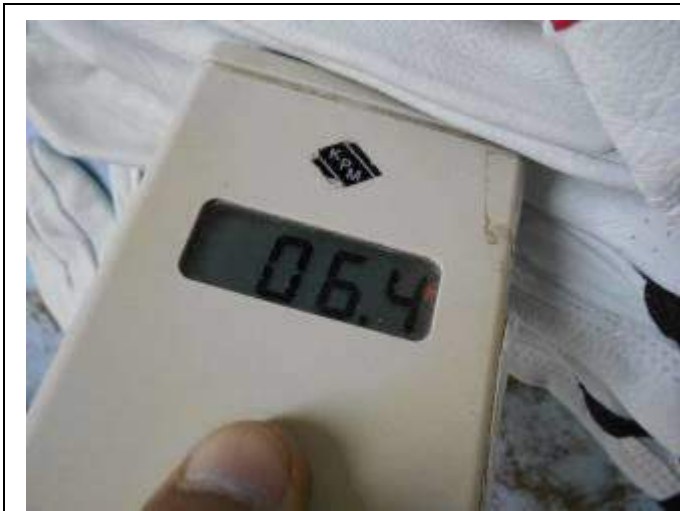
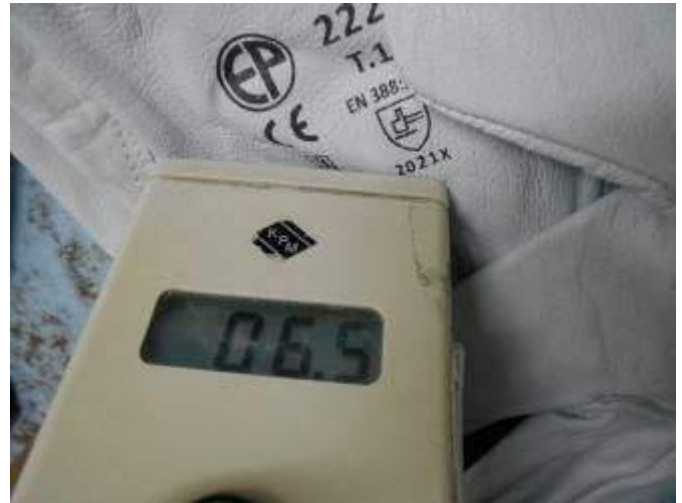
Check the moisture/humidity on the products including inside the carton as per the requirement of product.

Checked & found in between 5 to 6.8% which is matched the clients requirement

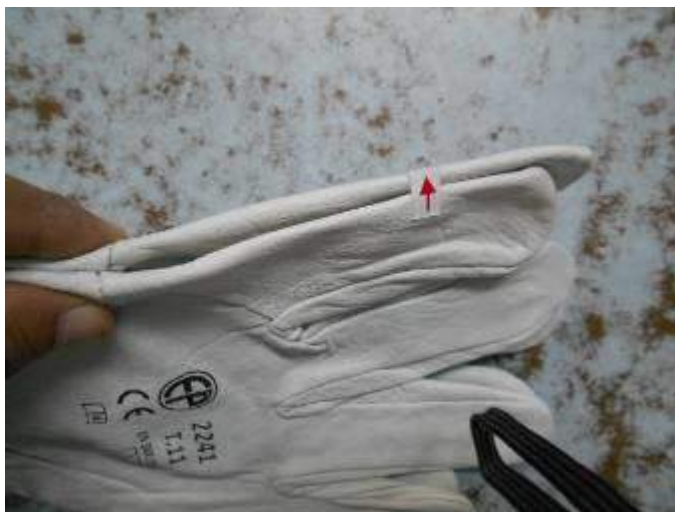
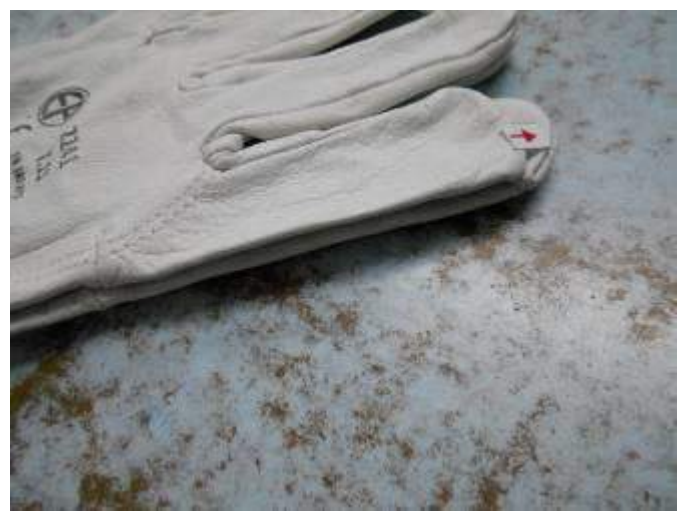
Defect number 1. Uneven index finger length in same pair	0	2	0
--	---	---	---

Sample size	Maximum Allowed	Total Defectives	Result	Comments
CRI :	0	0	Within AQL	Satisfactory
MAJ :	10	19	Beyond AQL	Need rechecked & repacked then offer for re-inspection.
MIN :	14	1	Within AQL	Satisfactory

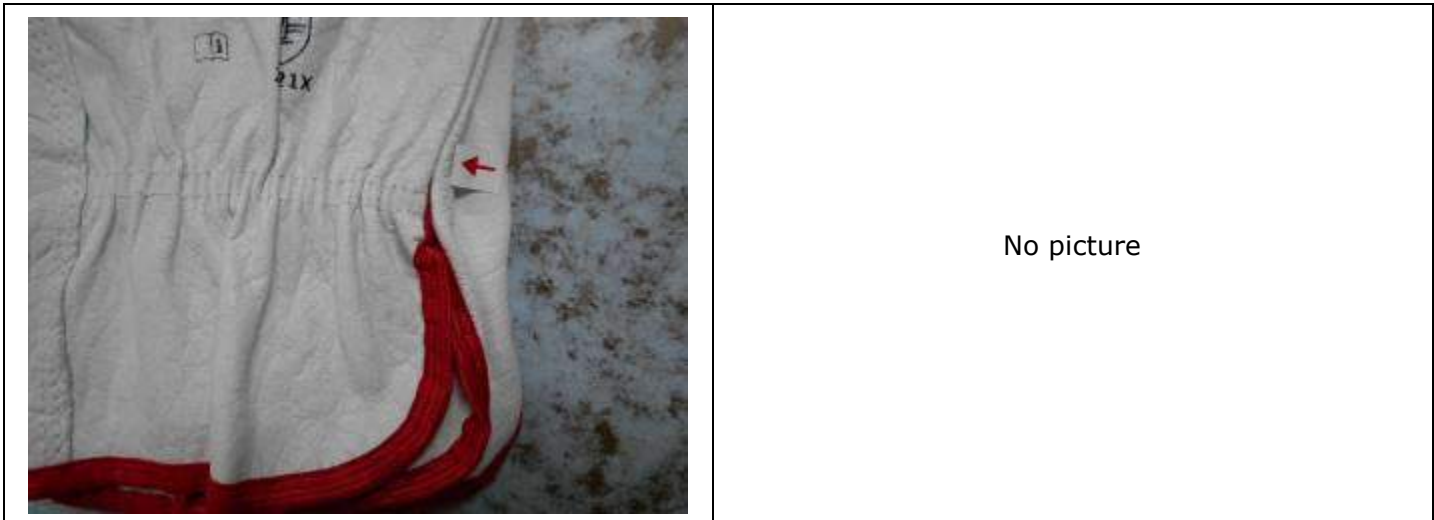
Defect number 2. Uneven width in same pair due to uneven elastic	0	1	0
--	---	---	---

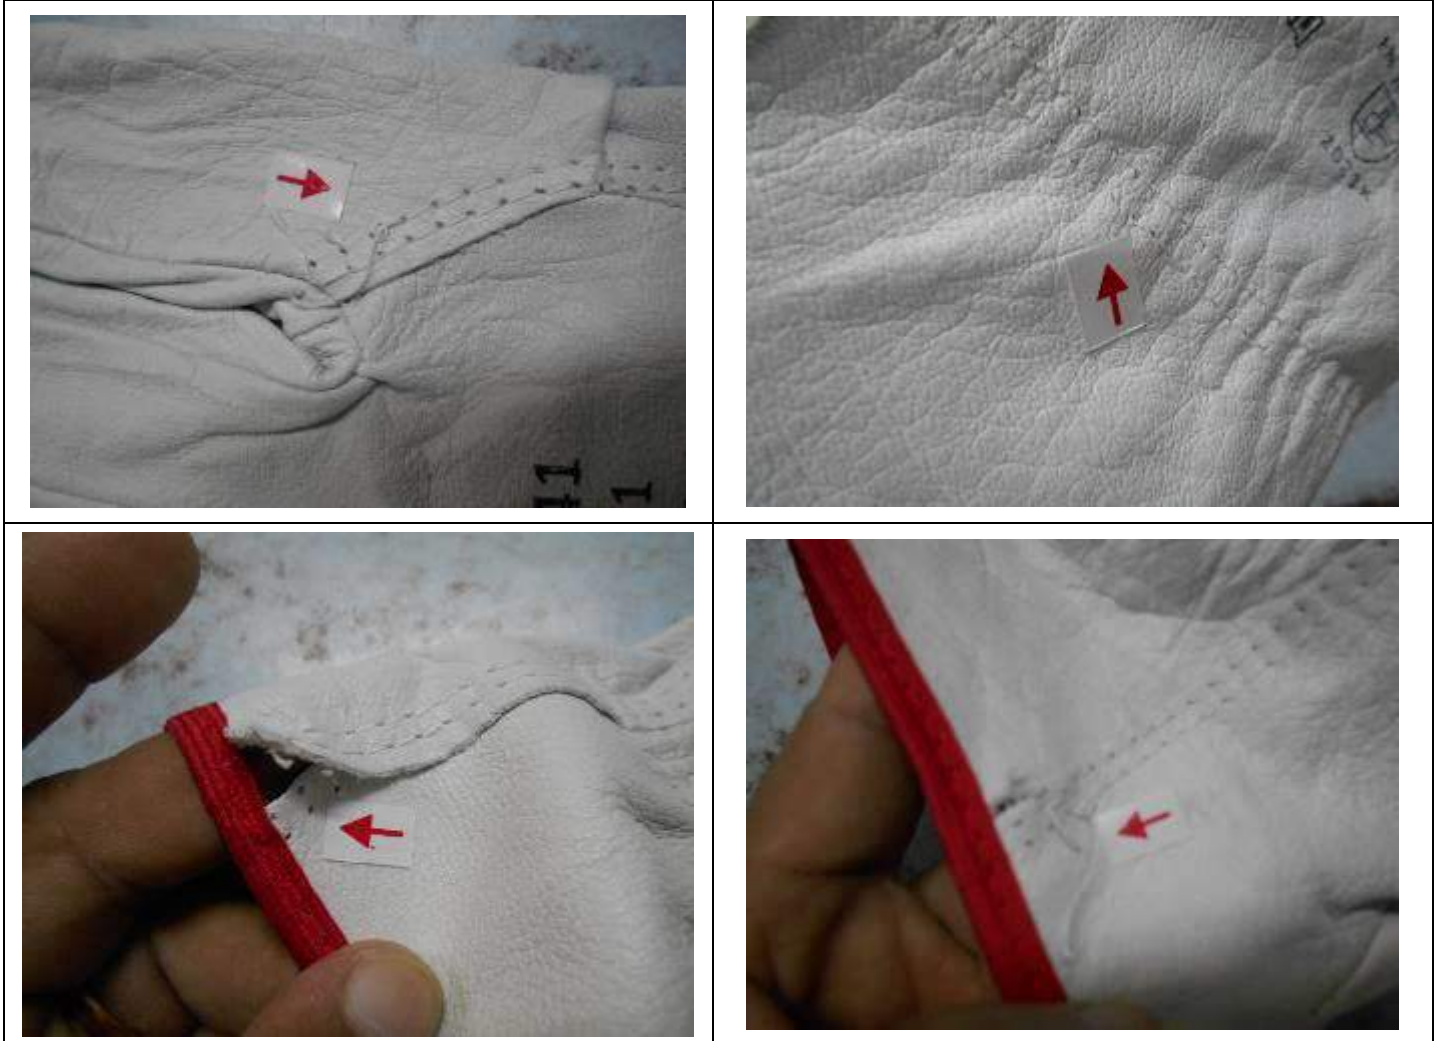
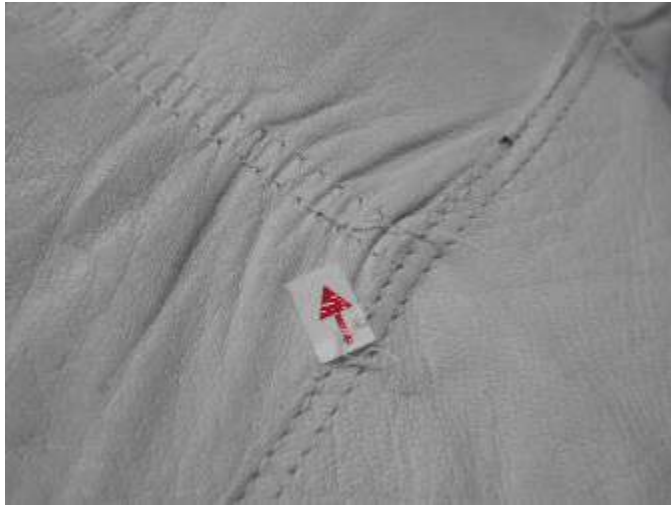
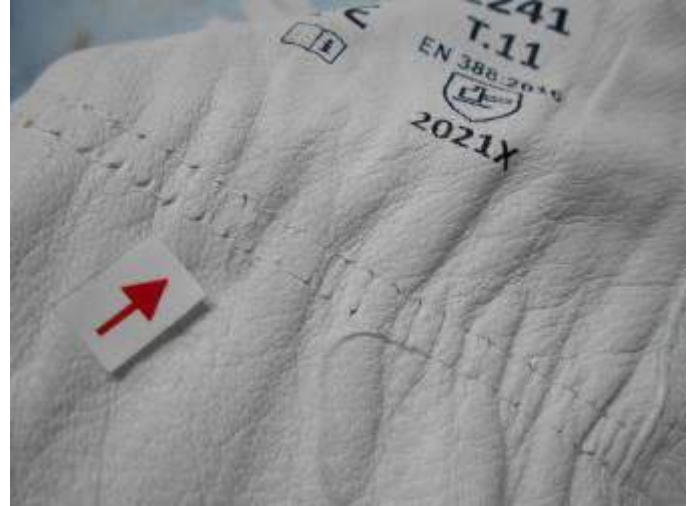
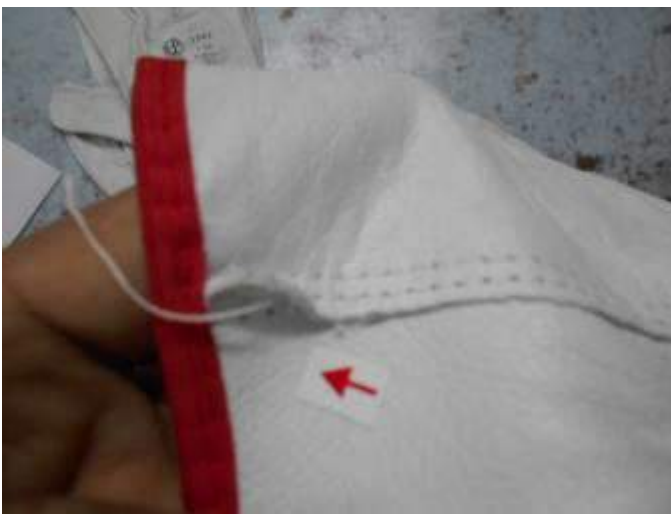
<p>Defect number 3. Broken seam</p>	0	7	0
--	---	---	---

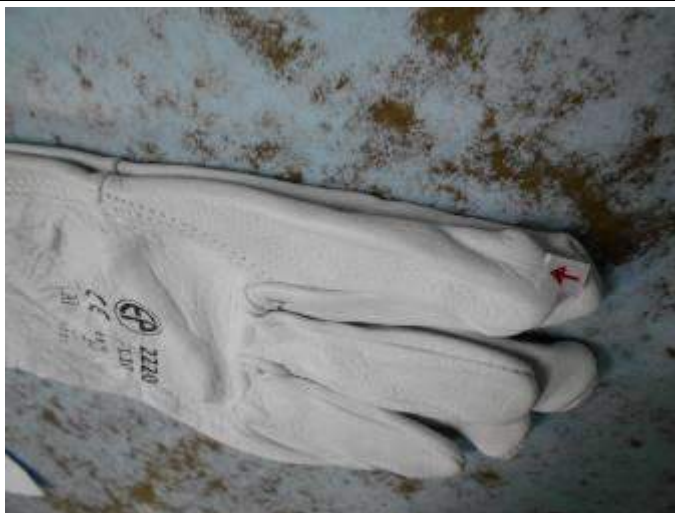
Defect number 1.

Uneven index finger length in same pair

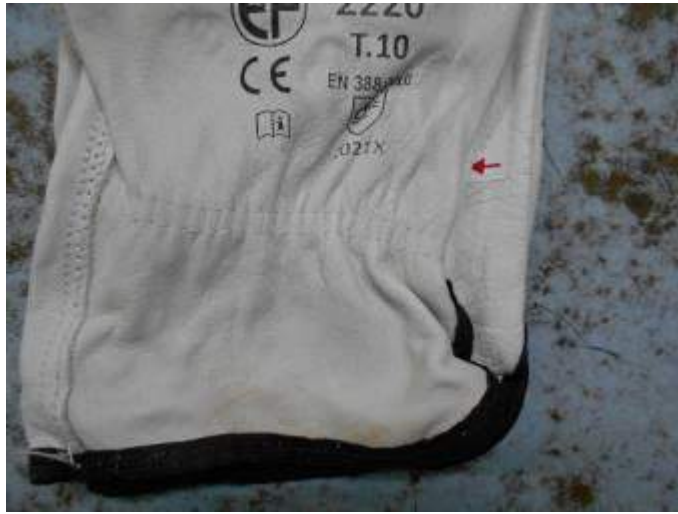
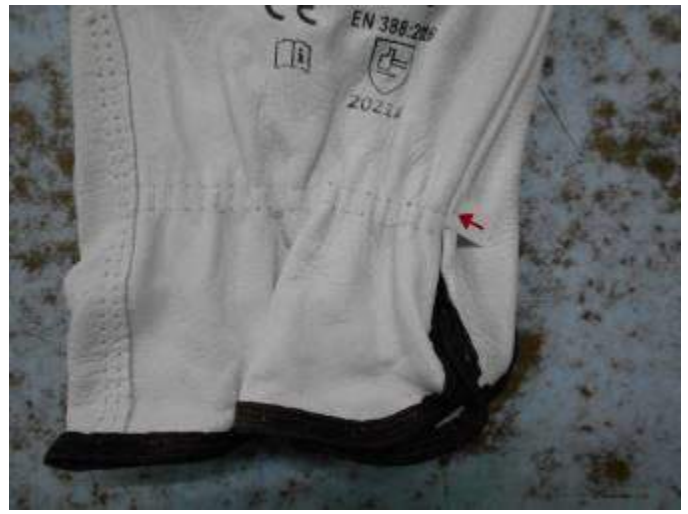
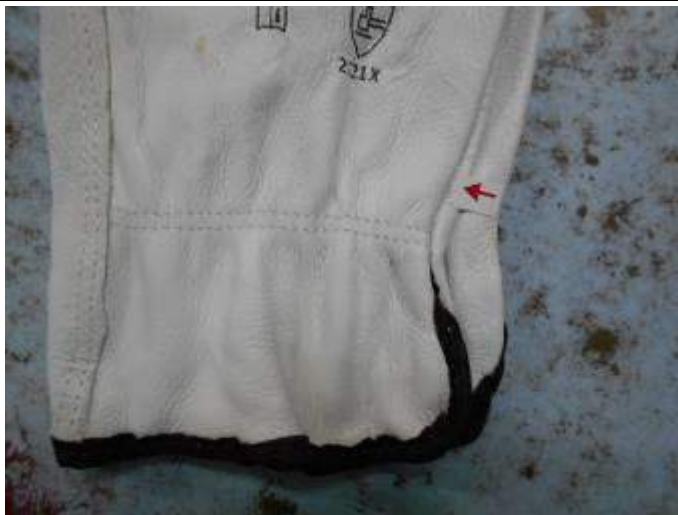
Defect number 2.

Uneven width in same pair due to uneven elastic

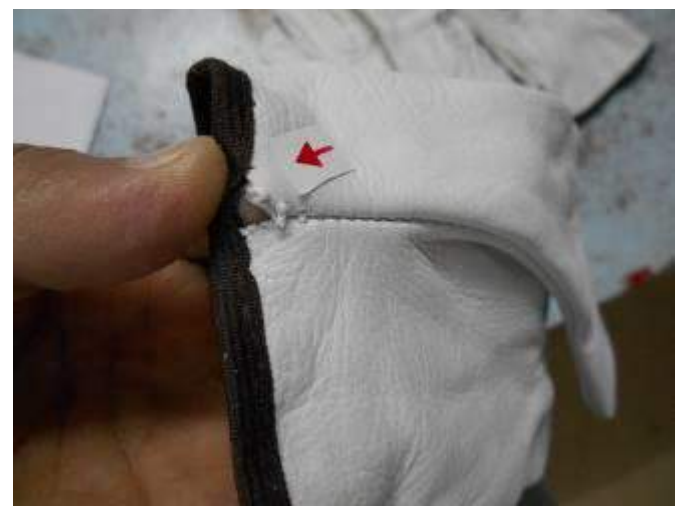
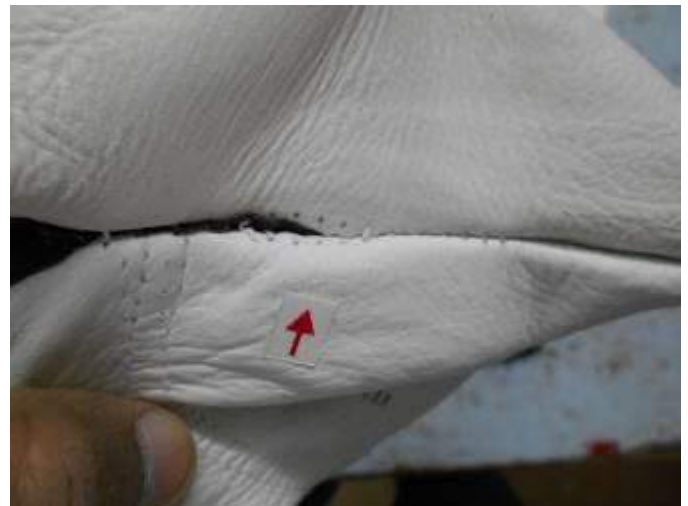
Defect number 3. Broken seam	0	3	0
--	---	----------	---

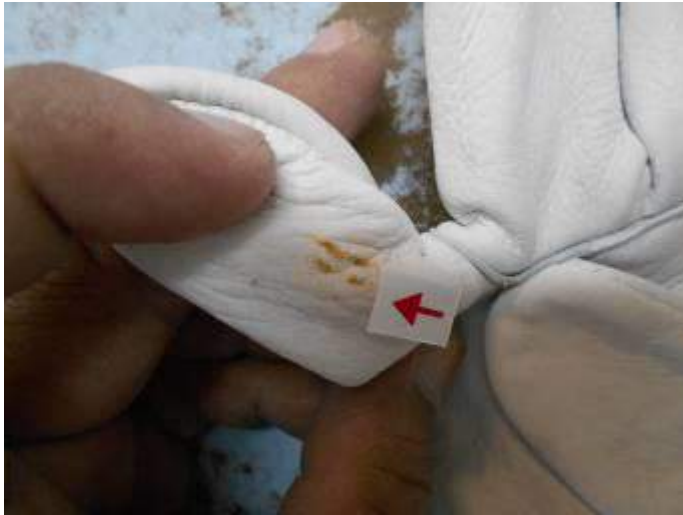
Defect number 5. Rust mark on leather	0	1	0
---	---	----------	---

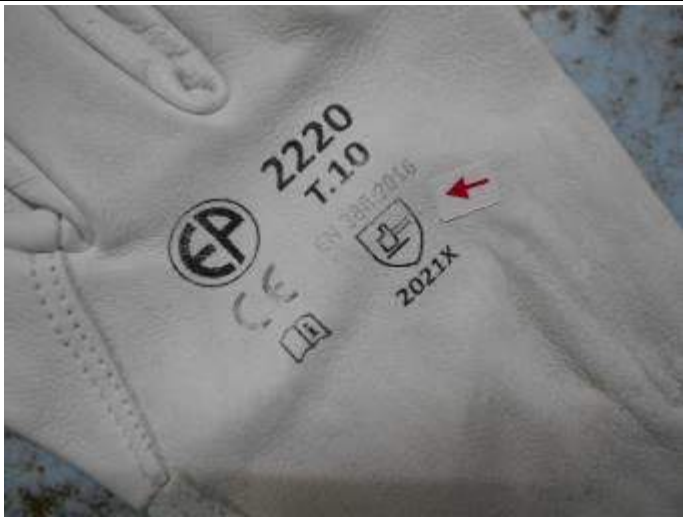
Defect number 6.

Improper/hazy print of artwork
