INSPECTION REPORT PART (IRP)

INSPECTION NO FOR CLIENT REFERENCE:	IRP-GL-091018
PRODUCT NAME:	Driving Gloves.
PO NUMBER:	xxxxxx
INSPECTION DATE:	09 Oct 2018
INSPECTION LOCATION:	Kolkata
INSPECTOR NAME:	Sunny Khan
FACTORY DETAILS:	ISP
CUSTOMER NAME :	EP

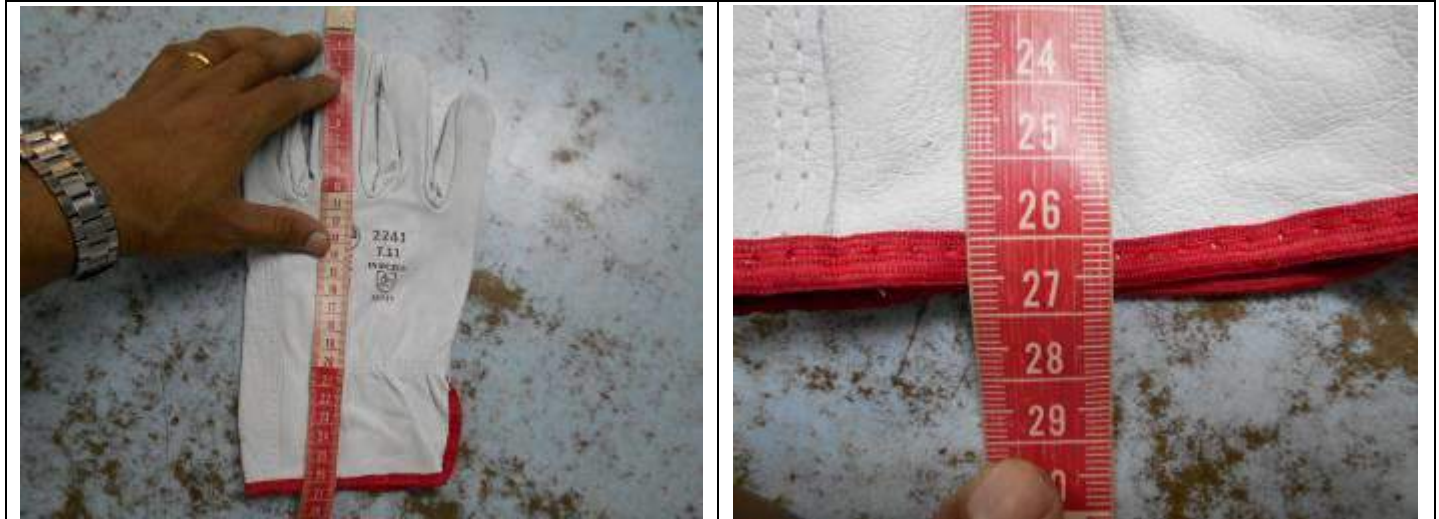
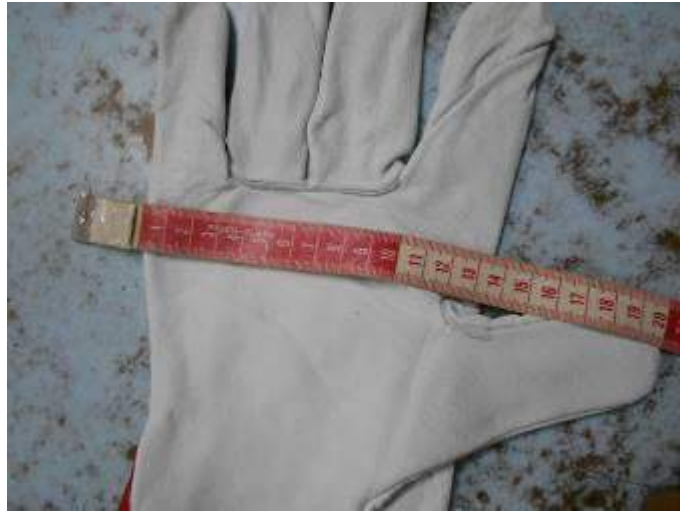
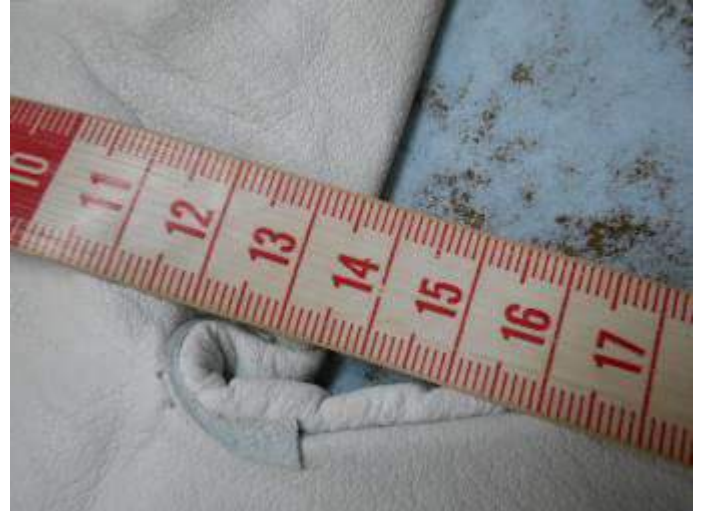
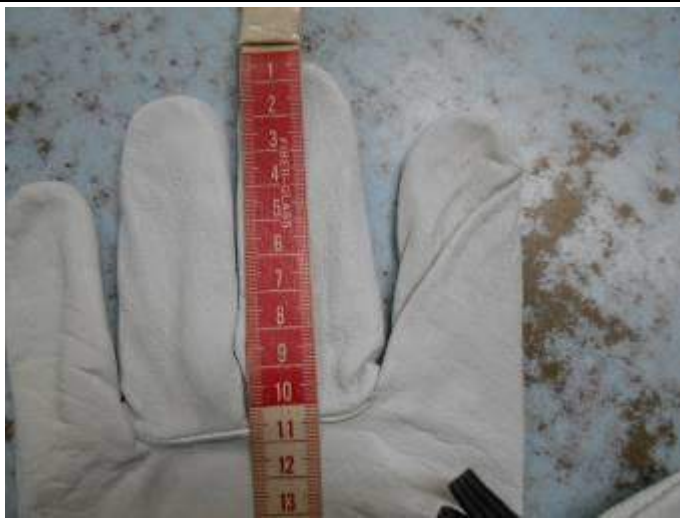
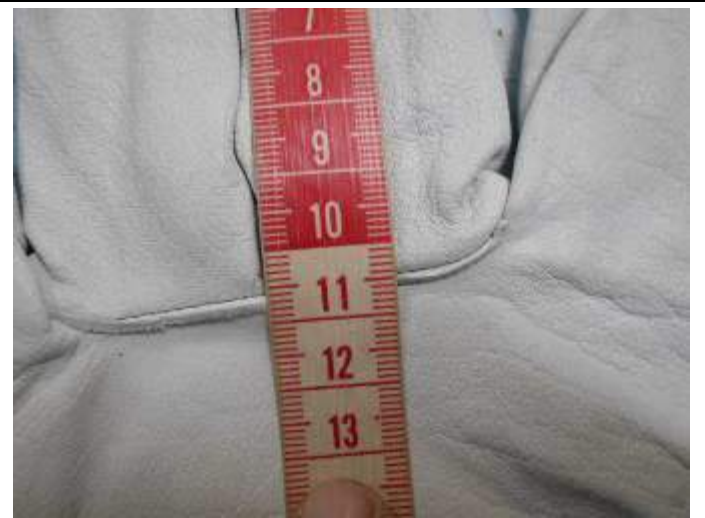
#2241

Expectation	Result	Comments
Client's Instructions: Total length x width x middle finger length..... #2241=26.5x13.5x10.5 #2220=25.5x12.5x10	Passed	Found satisfactory & which is +/- 0.3 cm against client's requirement.

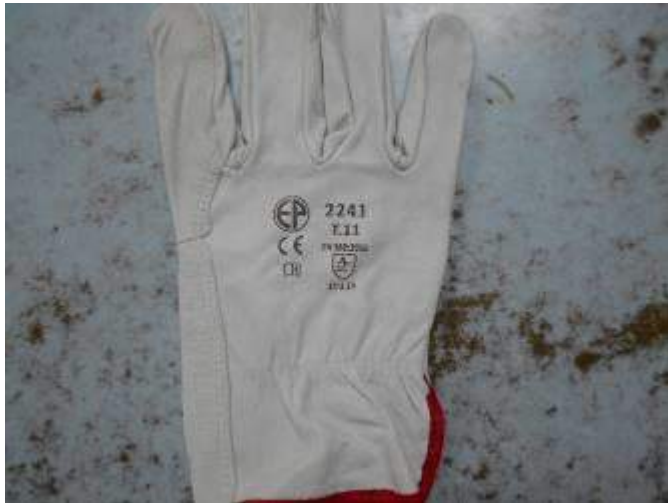
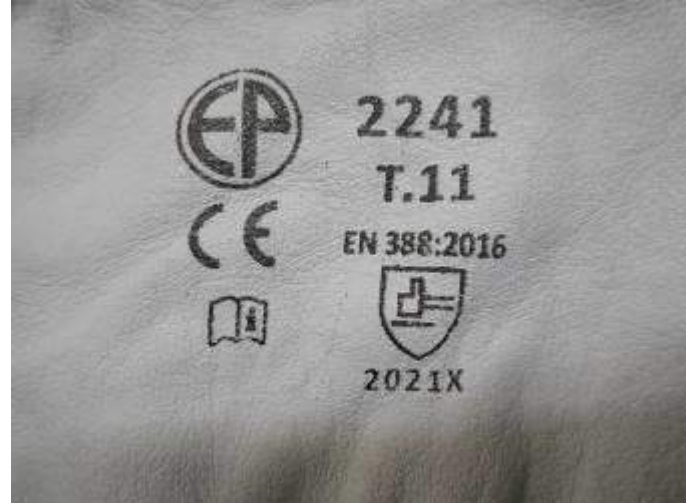
#2241

Expectation	Result	Comments
Appearance/General view of the logo//Artwork/Existing design:	Passed	Found satisfactory against clients provided Instruction. Please refer to below picture for the finding.
Logo/Artwork/Existing design's color:	Passed	Found satisfactory against clients provided Instruction. Please refer to below picture for the finding.

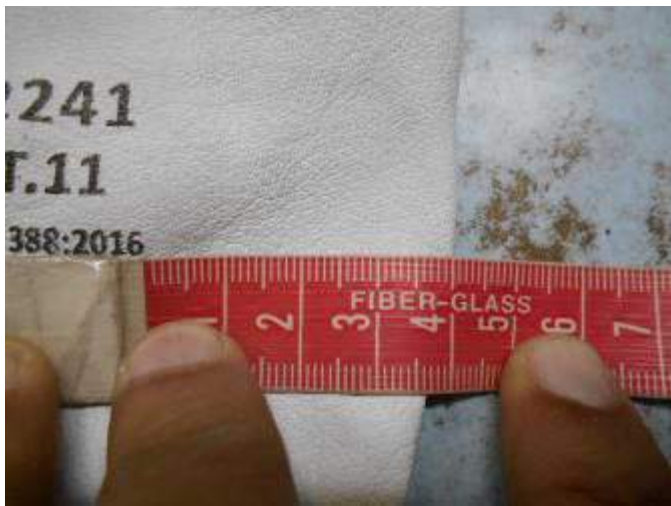
Positioning of artwork from right side :	Pending	No instruction provided by the client about the position & findings of the position for artwork of #2241 is 4 cm from right side edge of the glove to right side edge of the artwork. Position of the artwork for #2220 4 is cm from right side edge of the glove to right side edge of the artwork.
Alignment and parallelism :	Passed	Found satisfactory, please refer to below pictures.

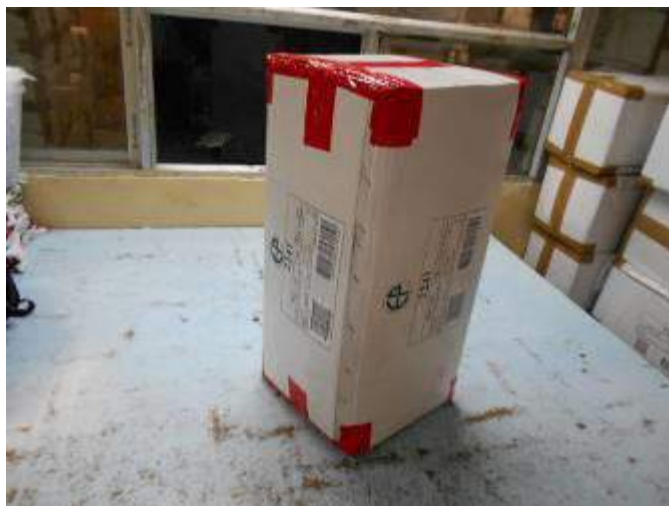
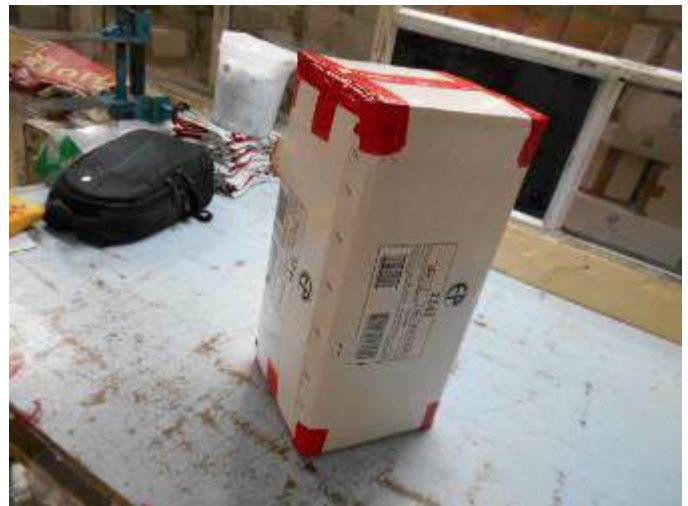
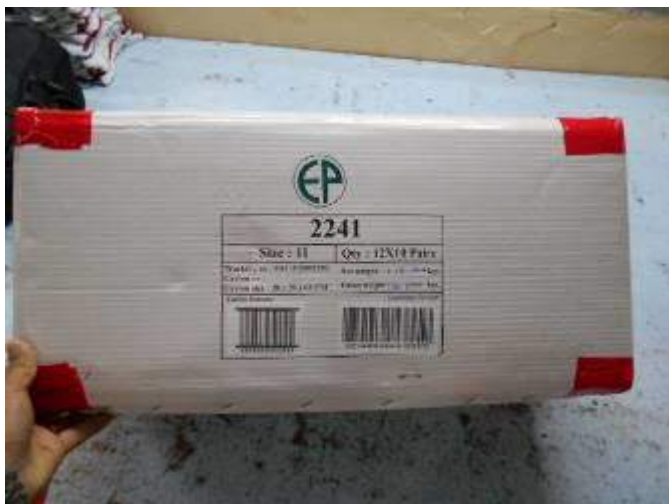
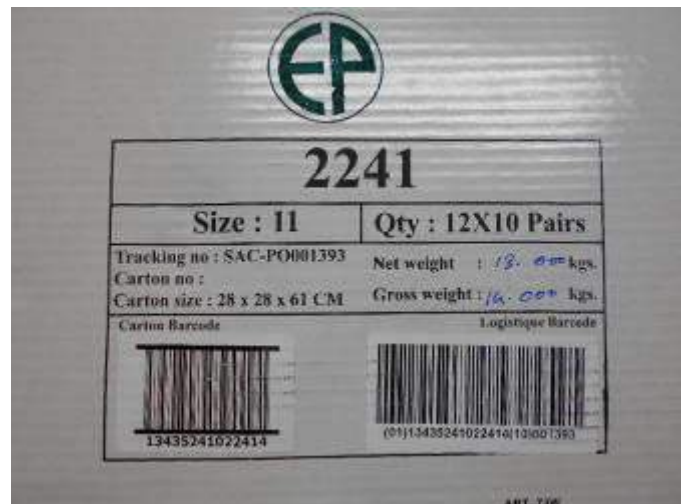
#2241

Expectation	Result	Comments
Client's Instructions:	Passed	Found satisfactory against clients provided instruction & attached picture which is same for all side of the carton. Please refer to below pictures.

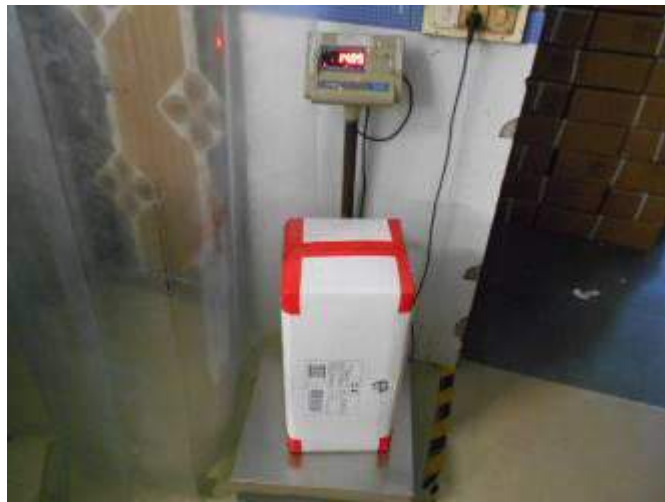
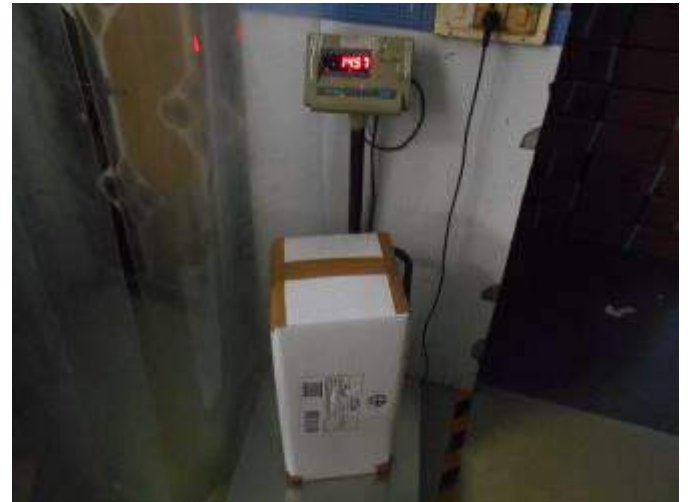
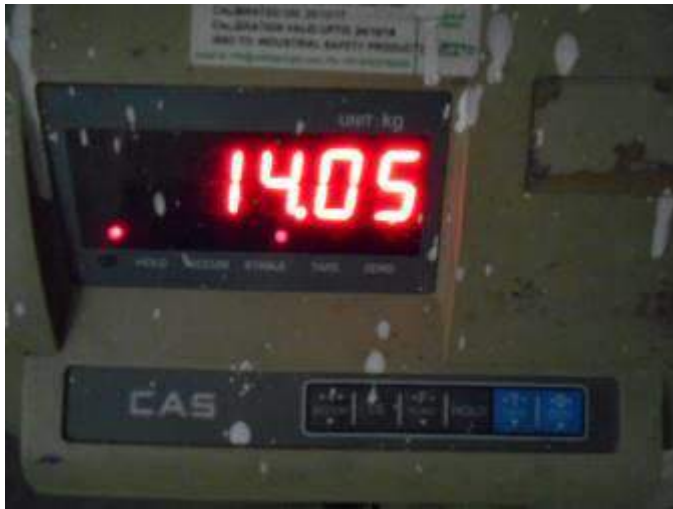
#2241

Expected Result	Result	Comments
Client's Instructions:	Passed	Found satisfactory against clients provided instruction, Please refer to below pictures.

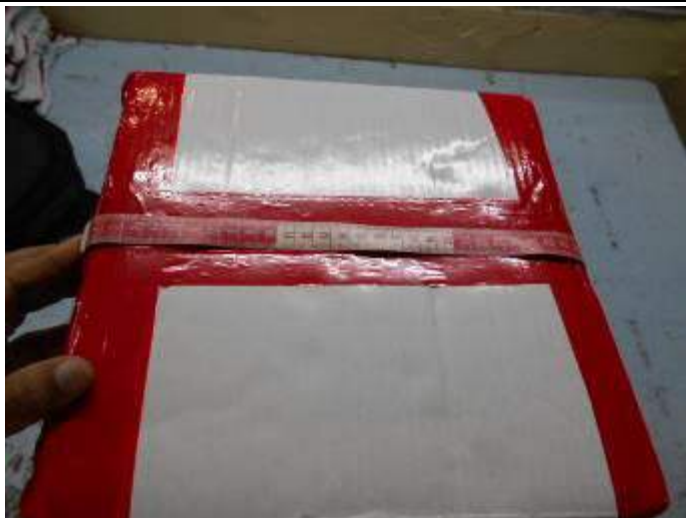
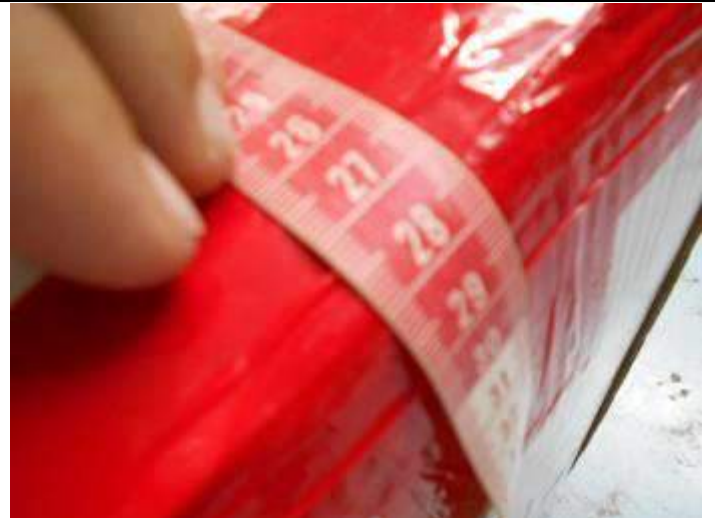
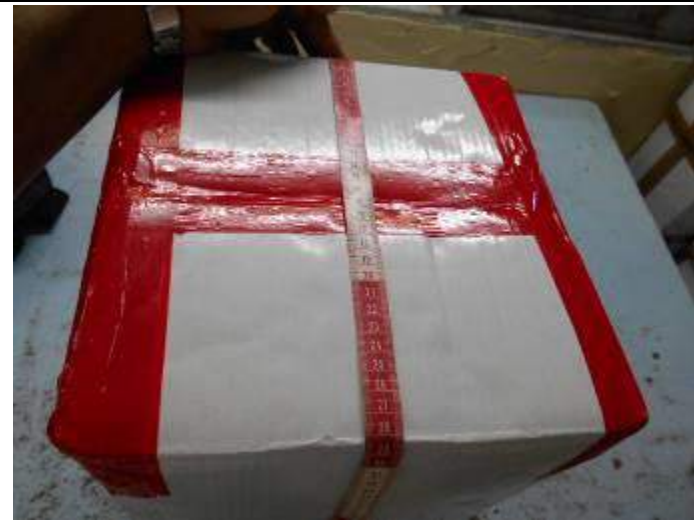
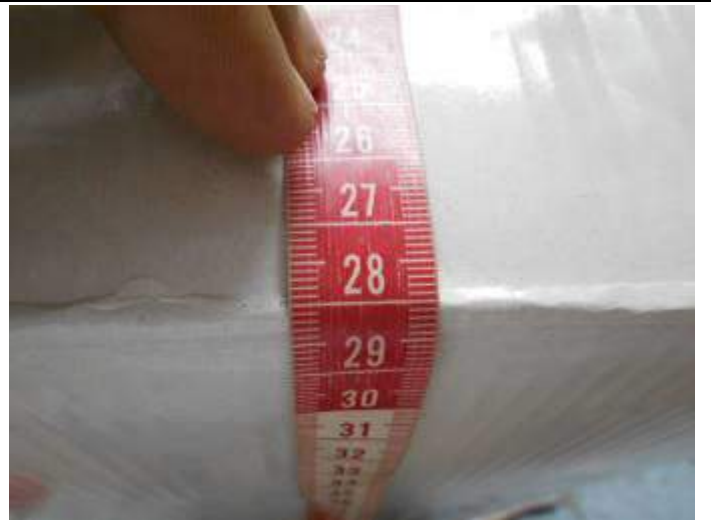
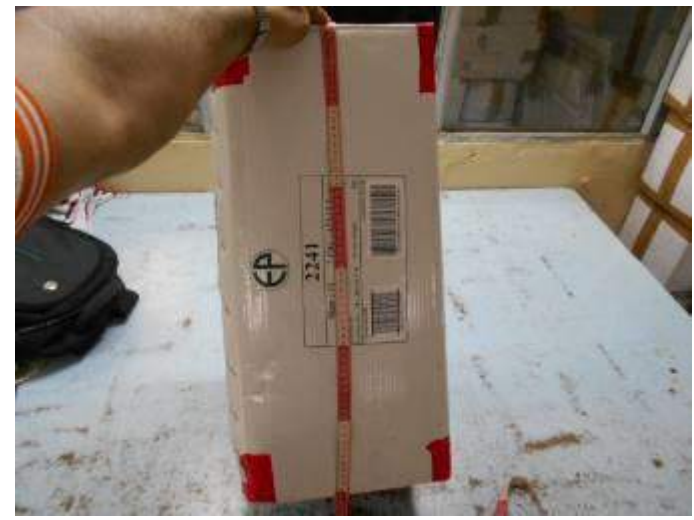
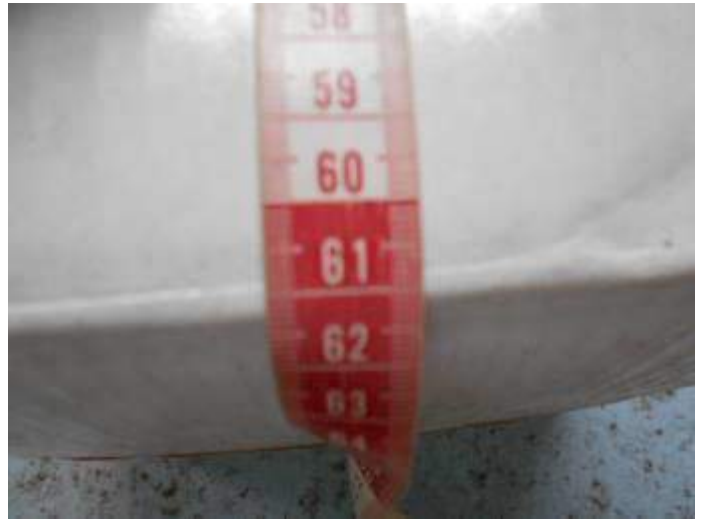
Expected Result	Result	Comments
Client's Instructions: L: cm x W: cm x H: cm	Passed	Found satisfactory against clients provided instruction & which is 28x28x61 cm in length x width x height wise for both item. Please refer to below pictures.

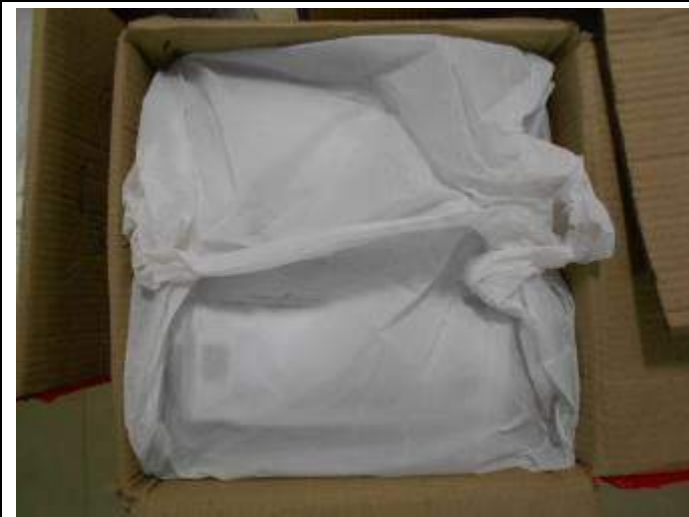
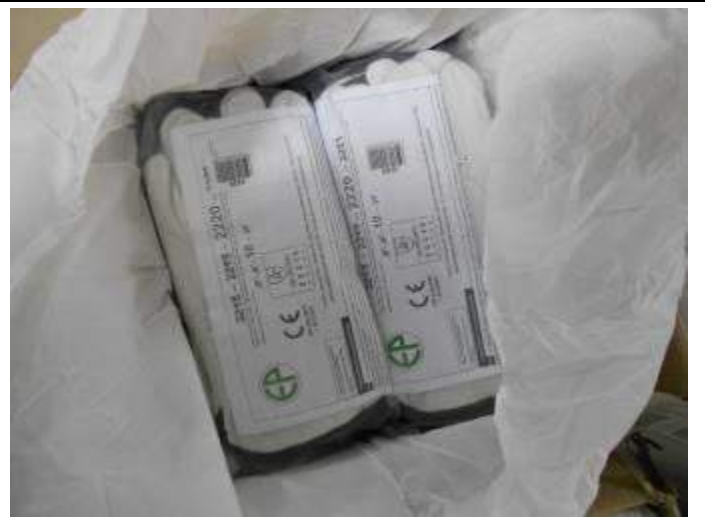
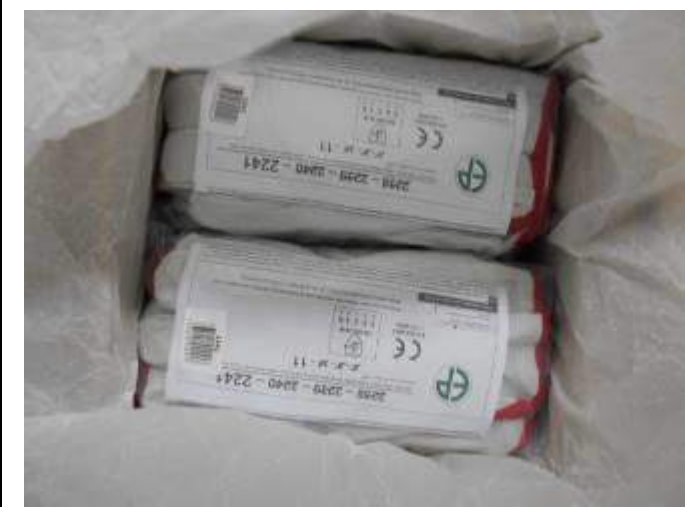
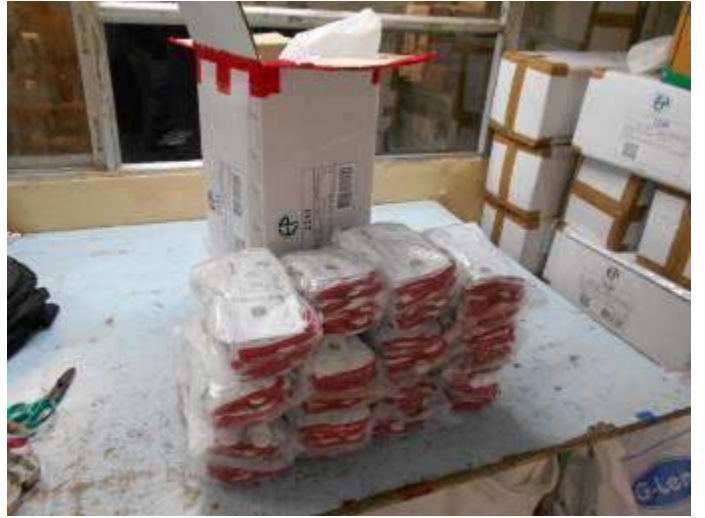
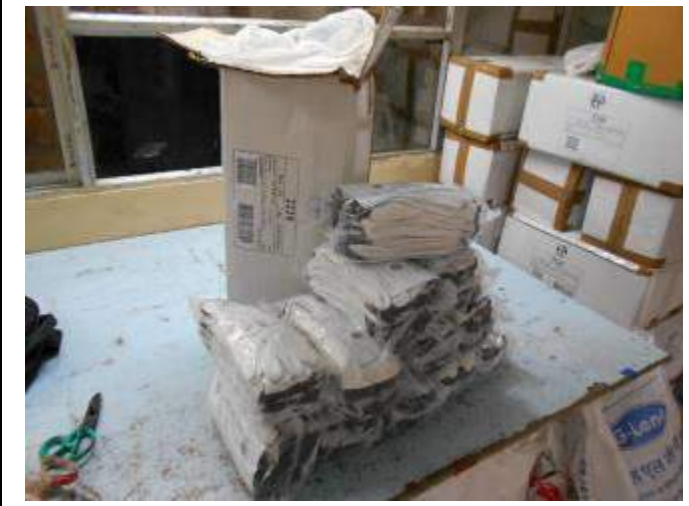
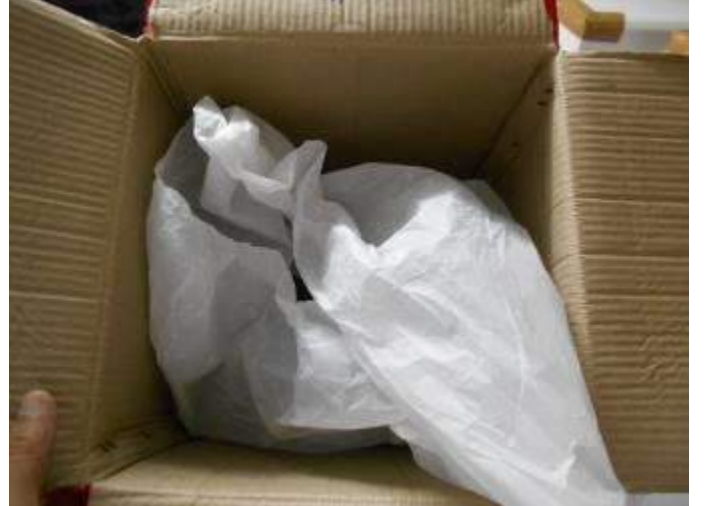
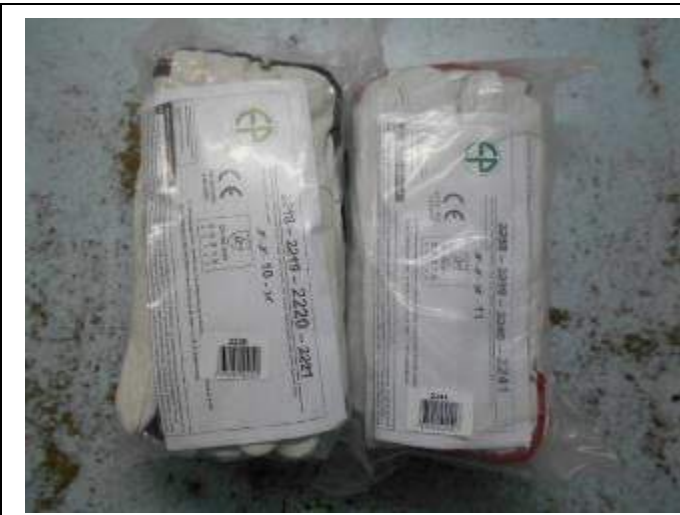
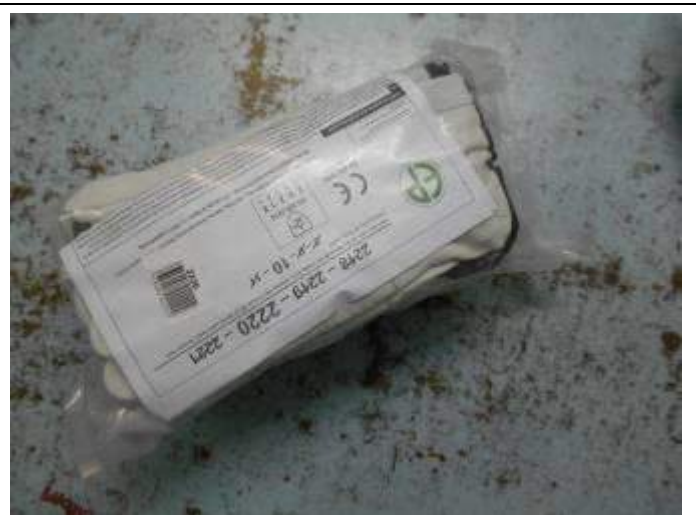
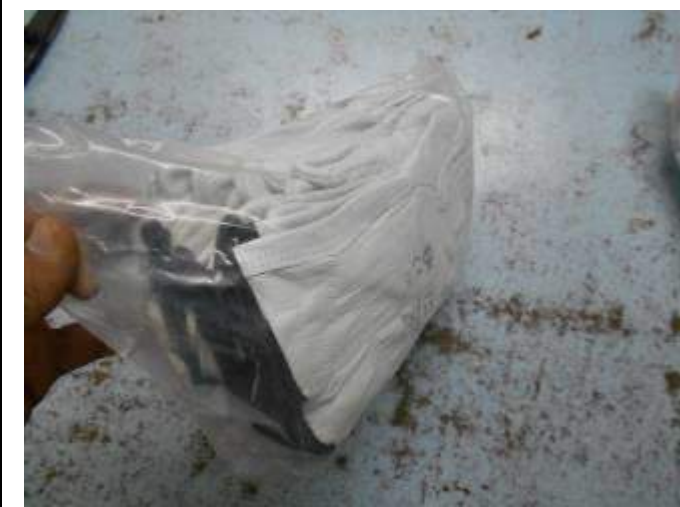
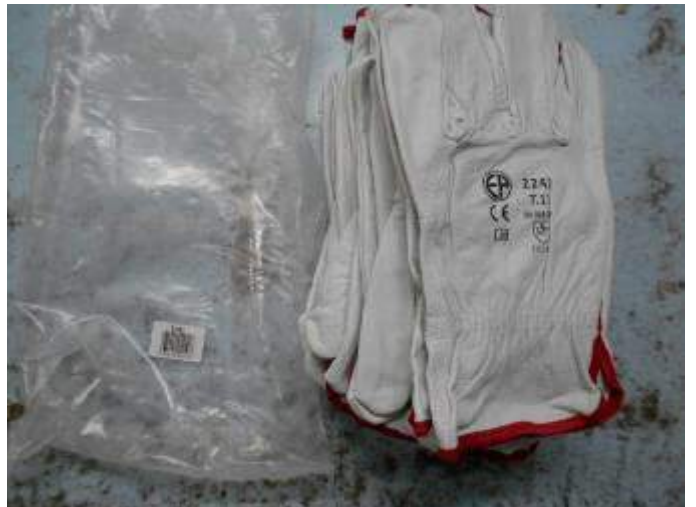
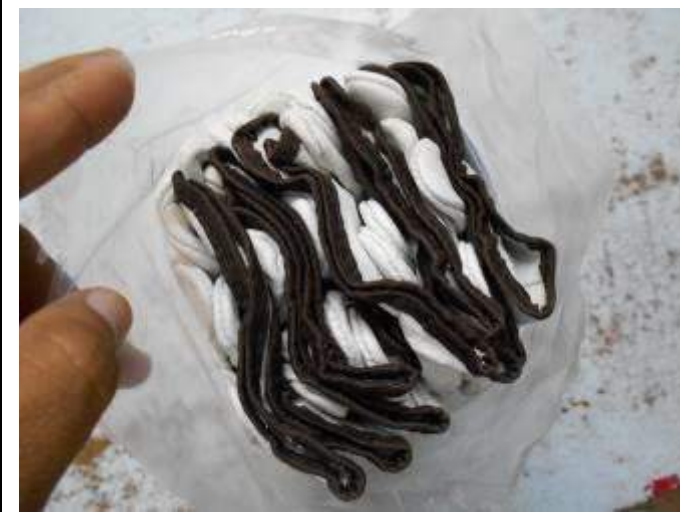
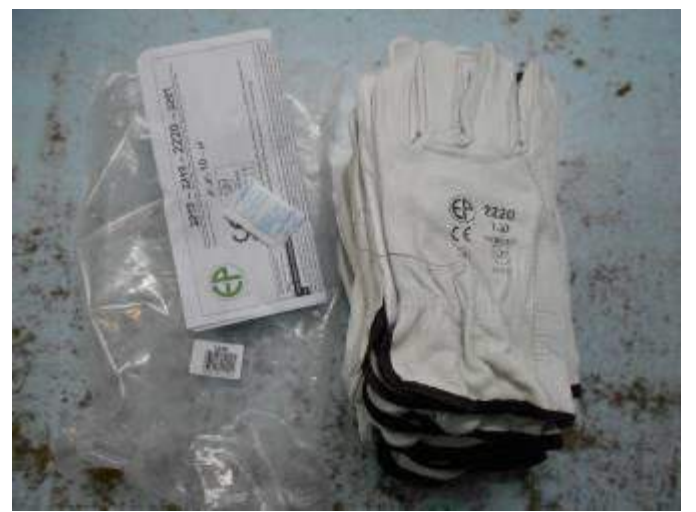
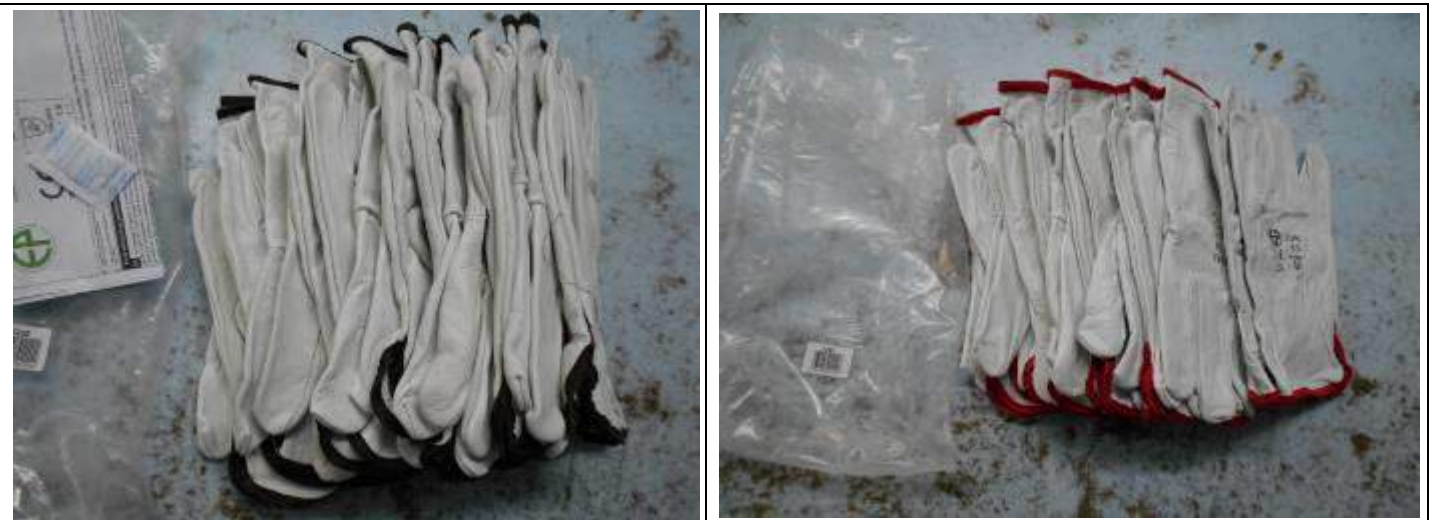
Expected Result	Result	Comments
Client's Instructions:	Passed	Found satisfactory against clients provided instruction. Please refer to below pictures.

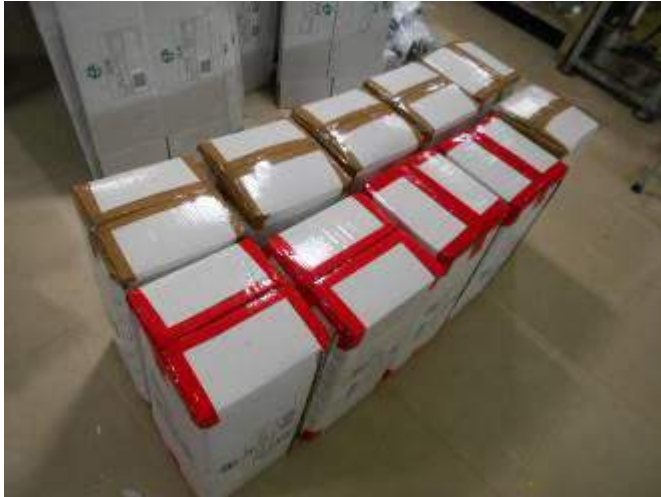
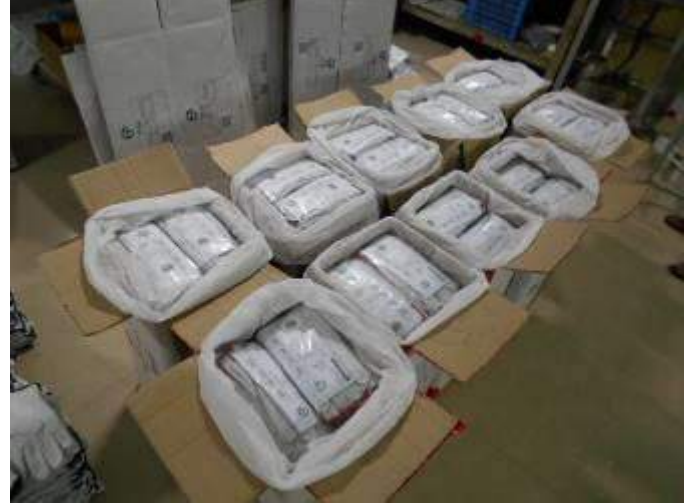
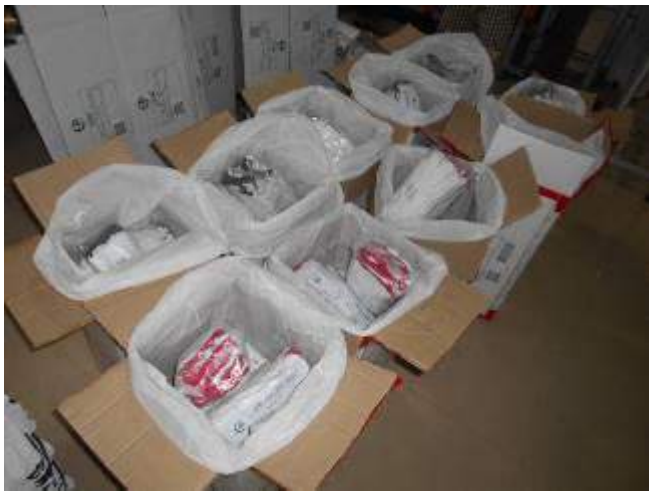
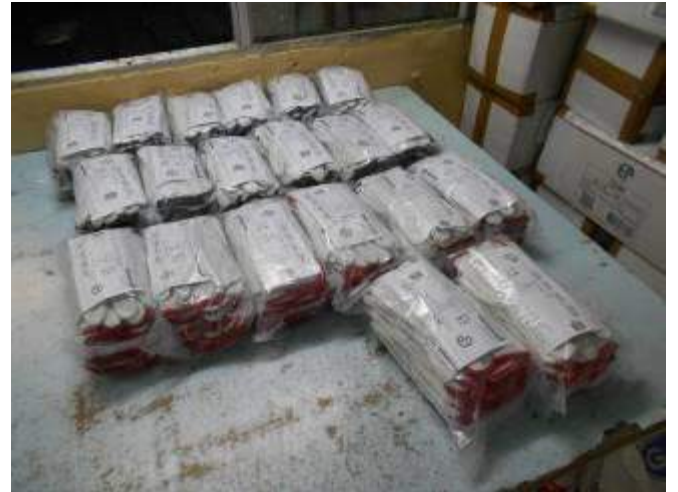
Test category	Comments from Inspector	Result
Either inspector allowed to perform the sampling size independently/randomly then the result is passed/ If not, the result is failed	Performed the full sampling size from randomly selected cartons.	Passed

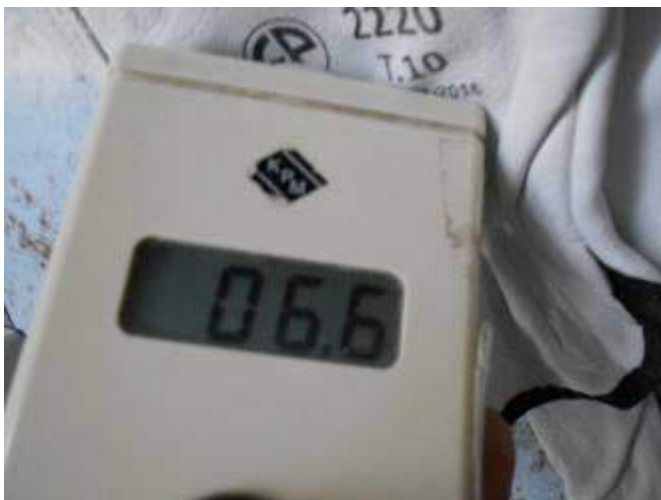
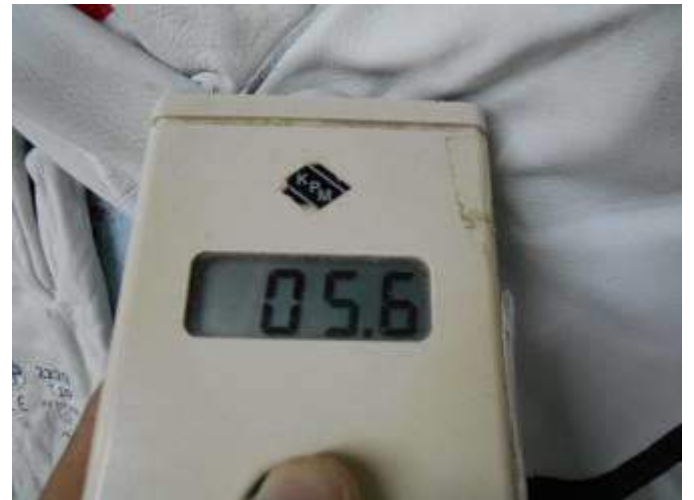
Check the moisture/humidity on the products including inside the carton as per the requirement of product.

Checked & found in between 5 to 6.8% which is matched the clients requirement

Passed

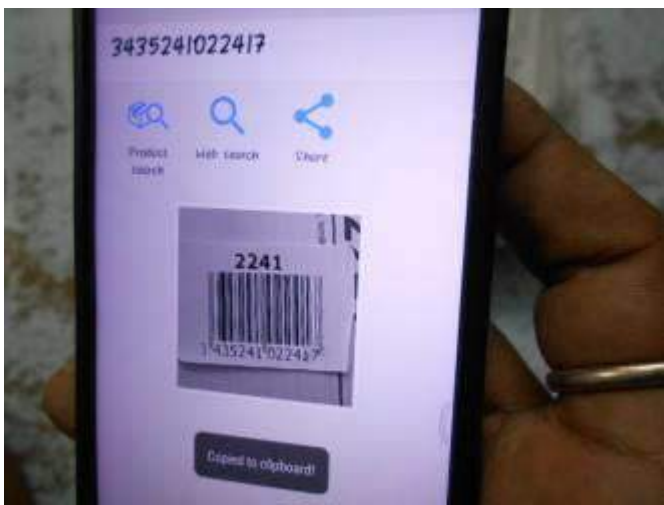
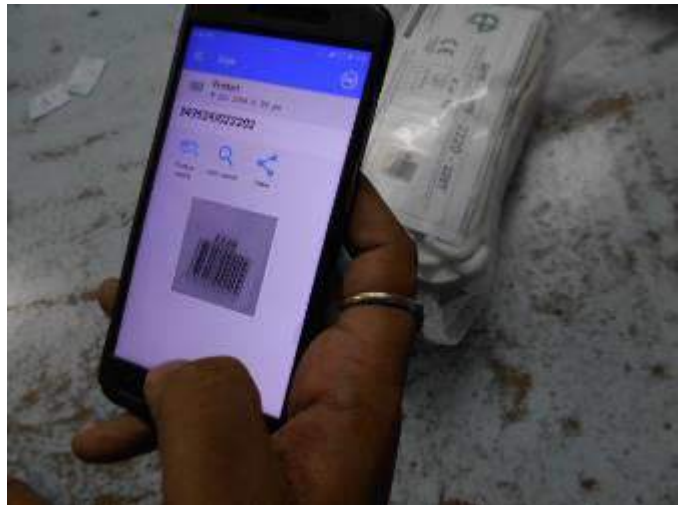
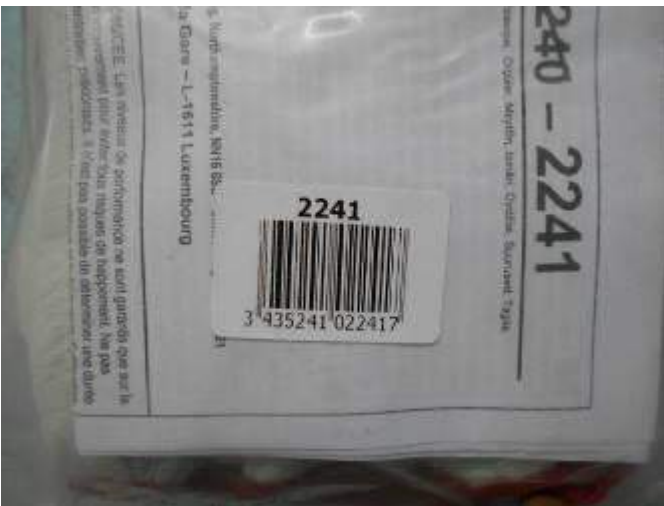
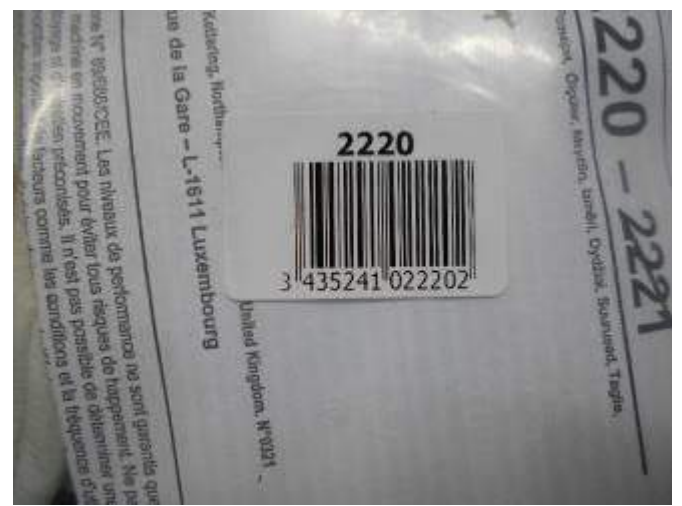
Perform a barcode checking test-The barcode should be the same and have the correct number; make sure that the correct barcode is on the correct product. (no mixed barcode for each reference)
-2 pairs of each item.

Checked & found satisfactory.

Passed

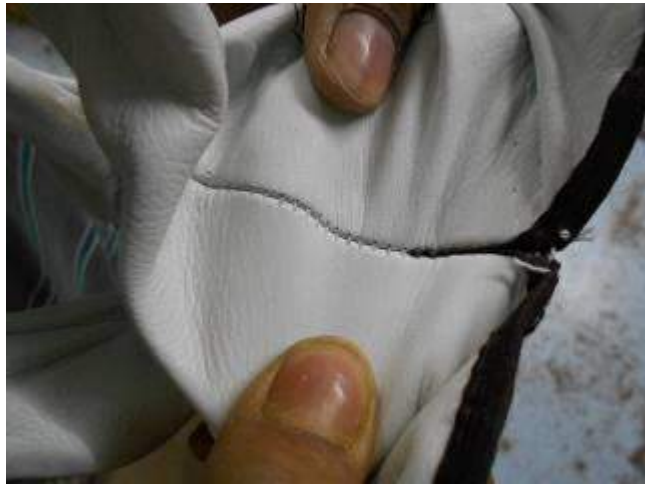
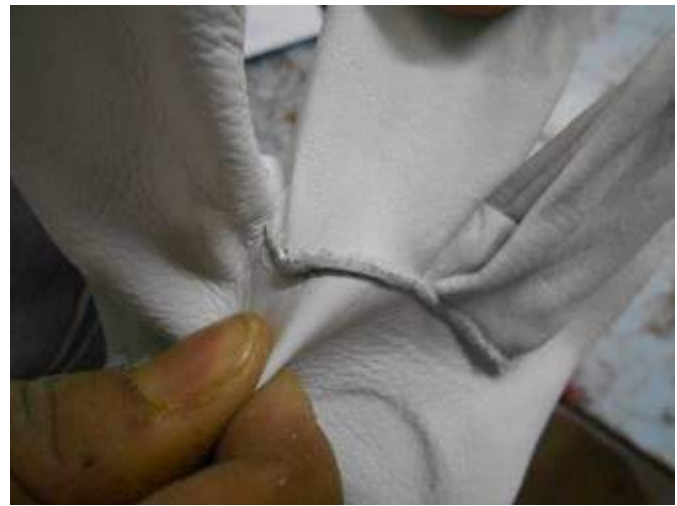
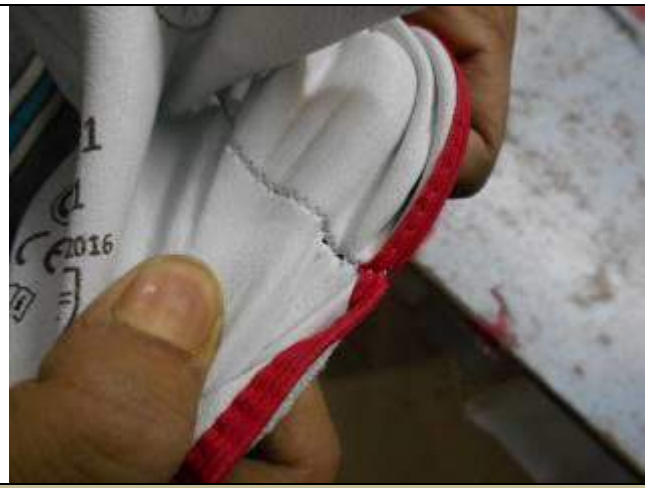
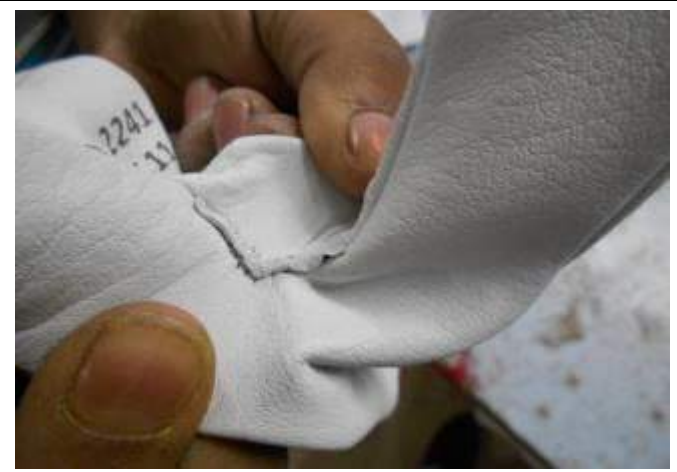
2. Check the seam strength on each part/pocket, especially on the handle or shoulder strap.-13 pairs

Checked & found satisfactory.

Passed

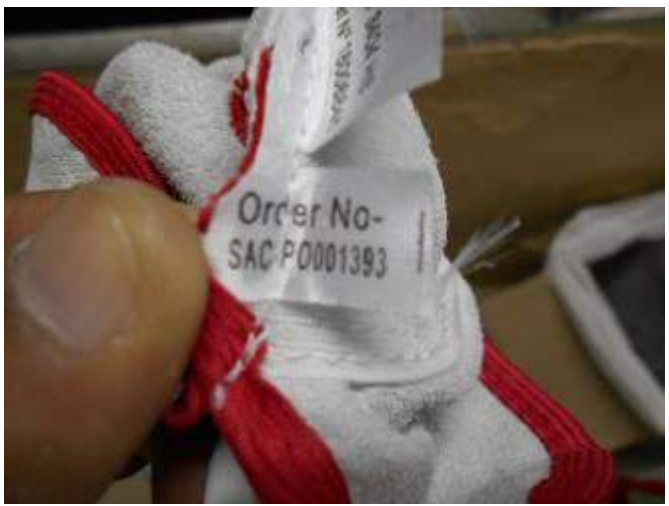
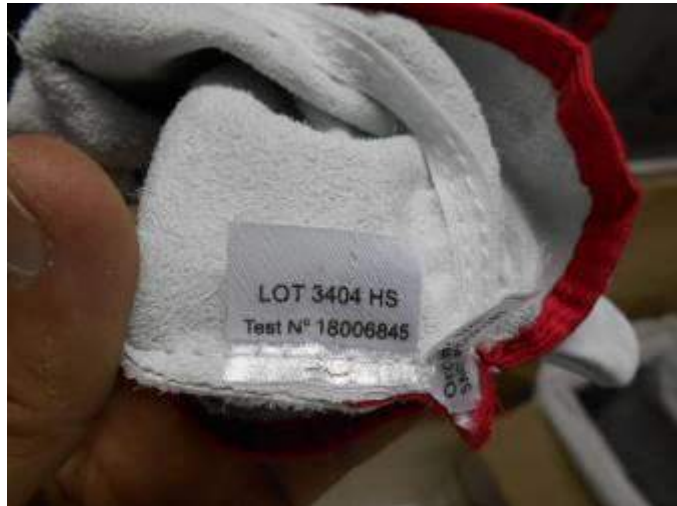
The importer information label/wash care label must not missing.-all inspected samples

Checked & found satisfactory.

Passed

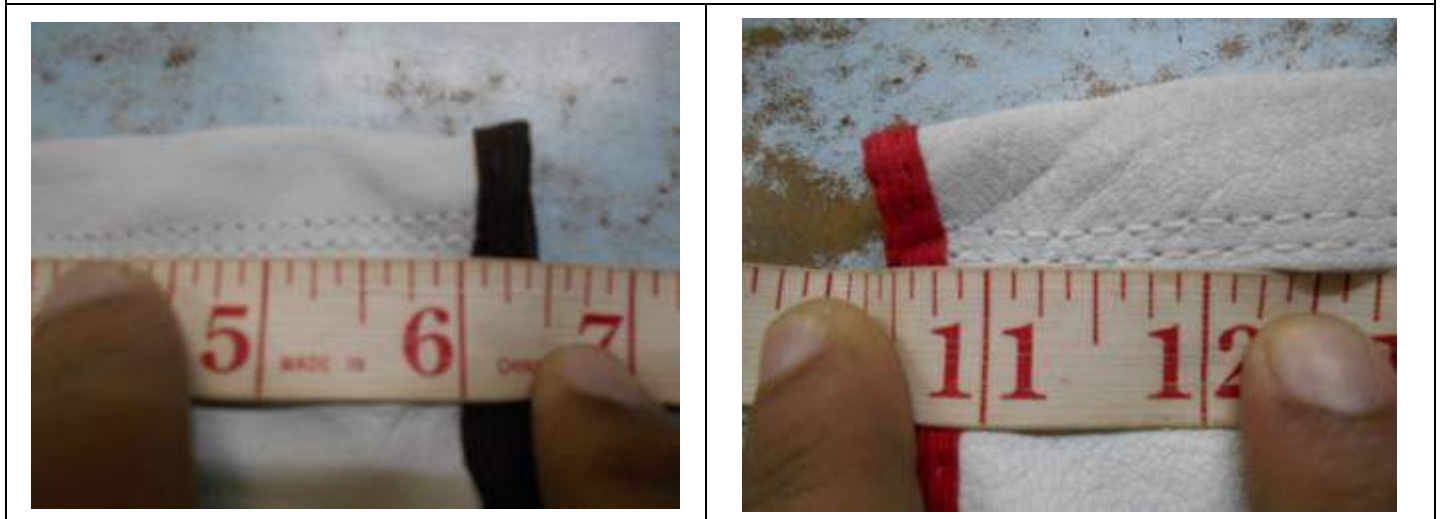
<p>Count and record the number of stitches per inch & compare with approved sample or clients provided instruction-5 pairs</p>	<p>No instruction given by the client to follow, checked & found SPI is in between 7 to 9</p>	<p>Pending</p>
---	---	-----------------------

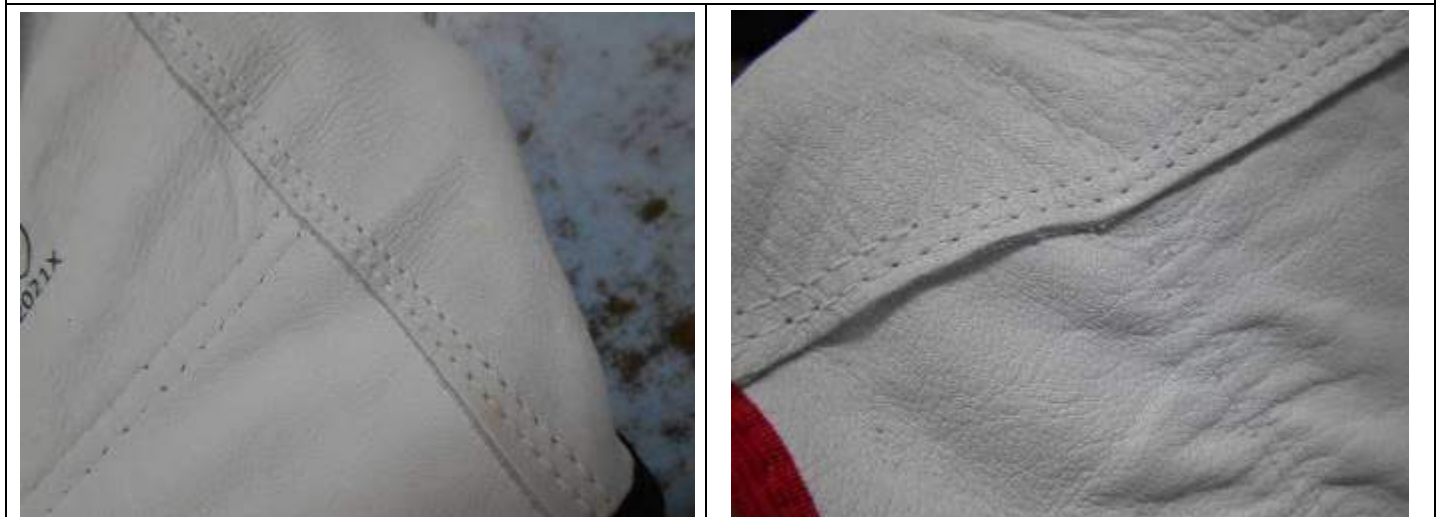
<p>Needle hole checking for joints- Check if there is any needle holes caused by the needle machine - perform this test on all the seams. Checked (20 Pairs)</p>	<p>Checked & found satisfactory.</p>	<p>Passed</p>
---	--	----------------------

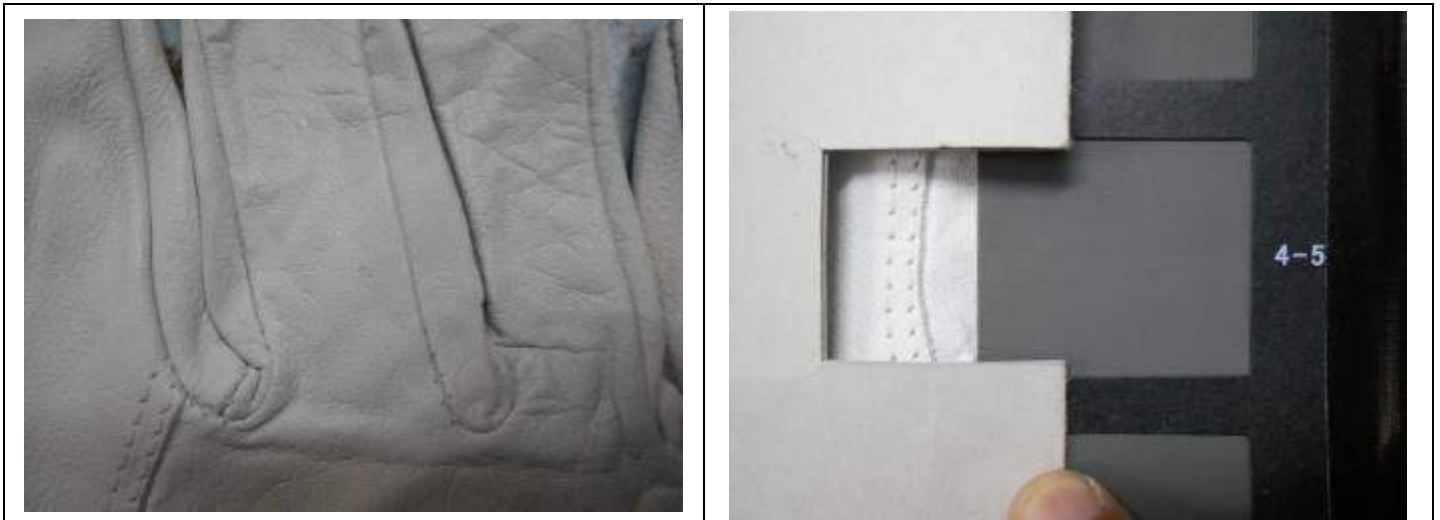
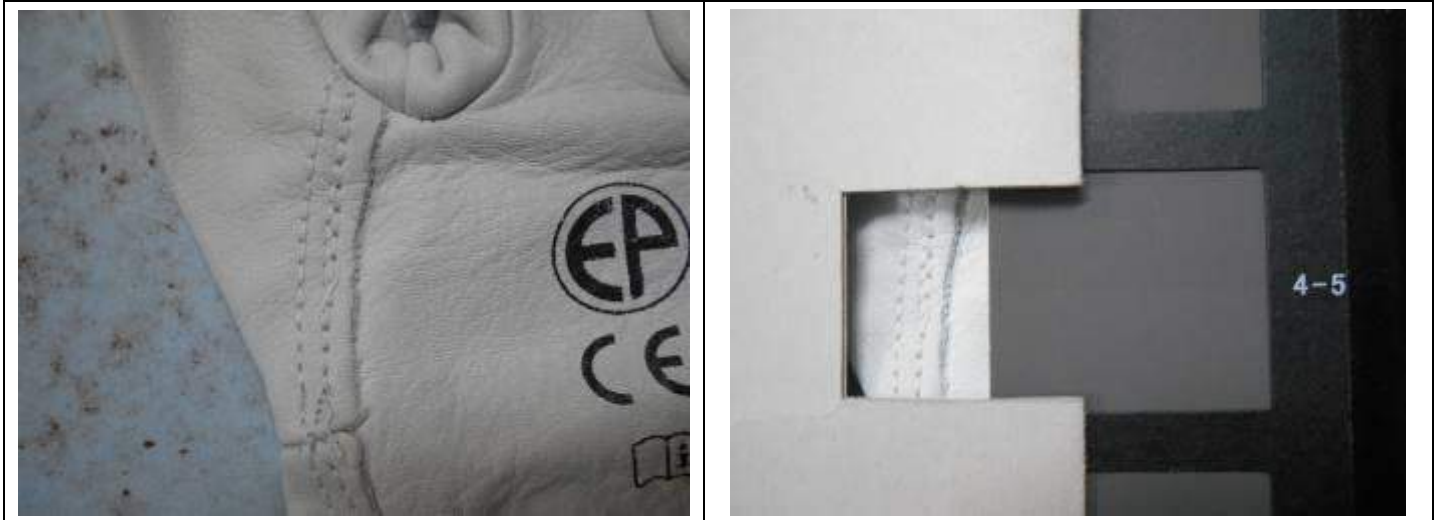
<p>1. Color shading check within the same piece: put the same color parts side by side and identify the different dye lot.</p> <p>2. Color shading check among all inspected pieces: place them side by side and identify the different dye lot.</p> <p>Minimum grey scale 4-5 is acceptable for color shading in the same piece and minimum grey scale 3-4 is acceptable for color shading among the different pieces</p> <p>- 13 pcs</p>	<p>Checked & found satisfactory.</p>	<p>Passed</p>
<p style="text-align: center;">Below is the pictures of within the piece difference:</p>

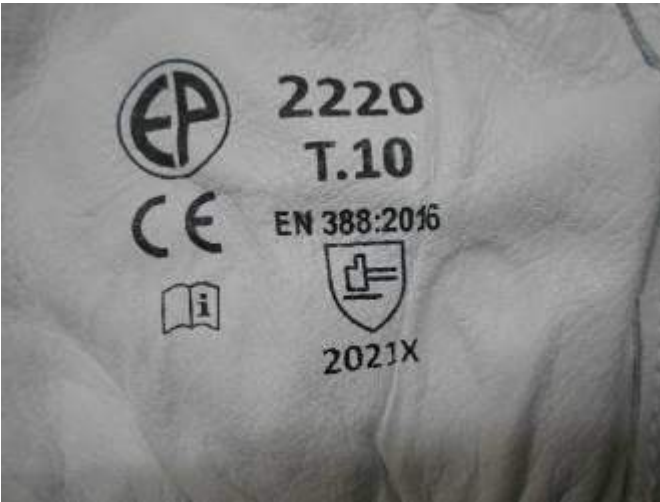
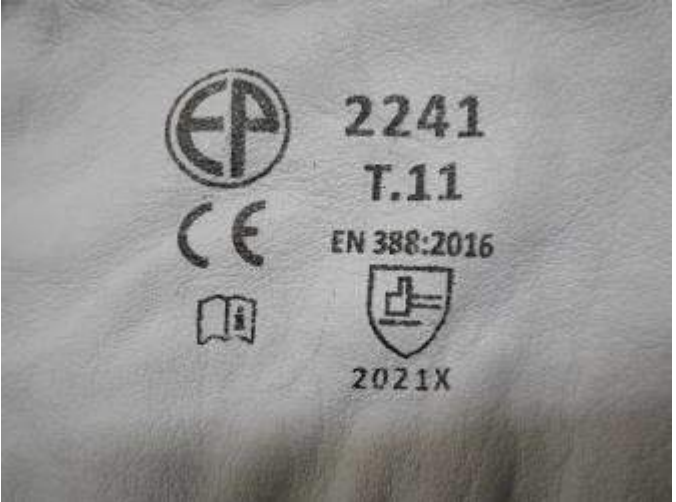
<p>Checked & found satisfactory.</p>	<p>Passed</p>
<p>Printing checking of artworks/printed area edges clarity, no blurry, proper color filling, no base visibility, uneven, crack, peel off. -all inspected samples Check if painting uneven, crack, peel off.</p>			
<p>Actual Pictures of above test section:</p>
