INSPECTION REPORT PART (IRP)

INSPECTION NO FOR CLIENT REFERENCE:	IRP-GL-091018
PRODUCT NAME:	Driving Gloves.
PO NUMBER:	xxxxxx
INSPECTION DATE:	09 Oct 2018
INSPECTION LOCATION:	Kolkata
INSPECTOR NAME:	Sunny Khan
FACTORY DETAILS:	ISP
CUSTOMER NAME :	EP

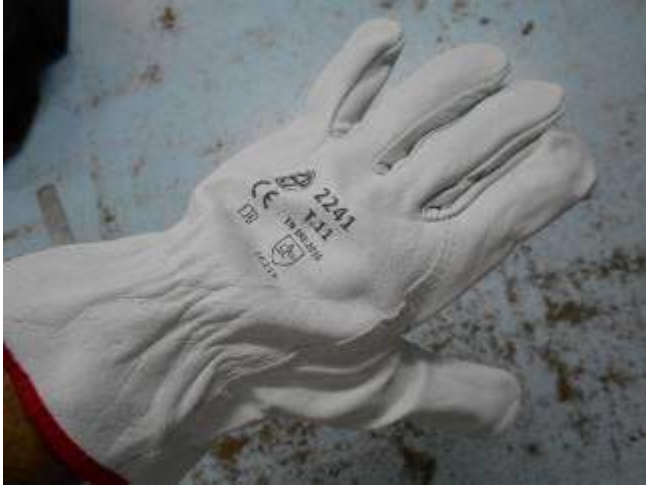
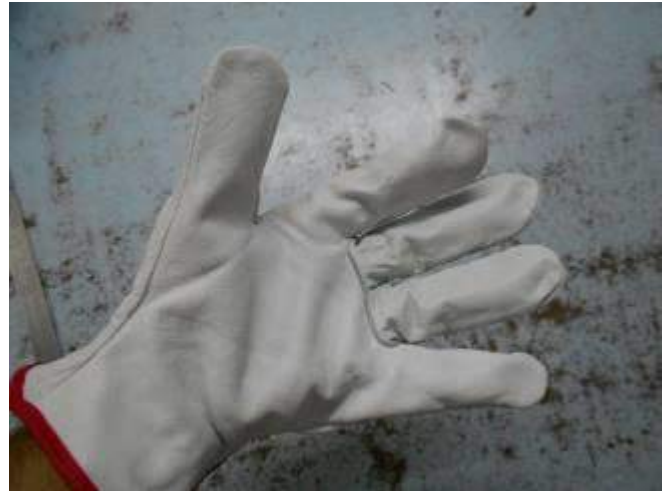
<p>Checked & found satisfactory.</p>	<p>Passed</p>
<p>Fitting check of the item as per size is appropriate for you- 8 pairs</p>			
<p>Actual Pictures of above test section:</p>

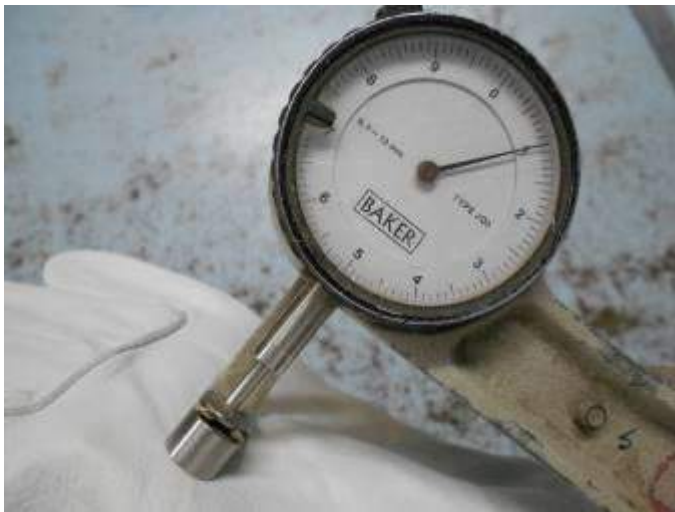
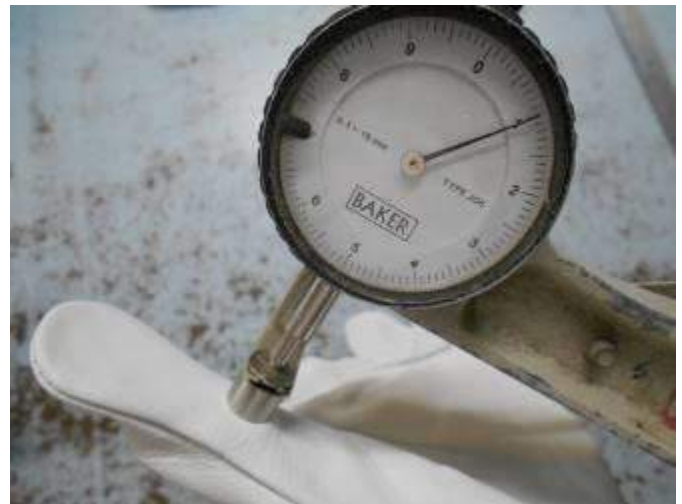
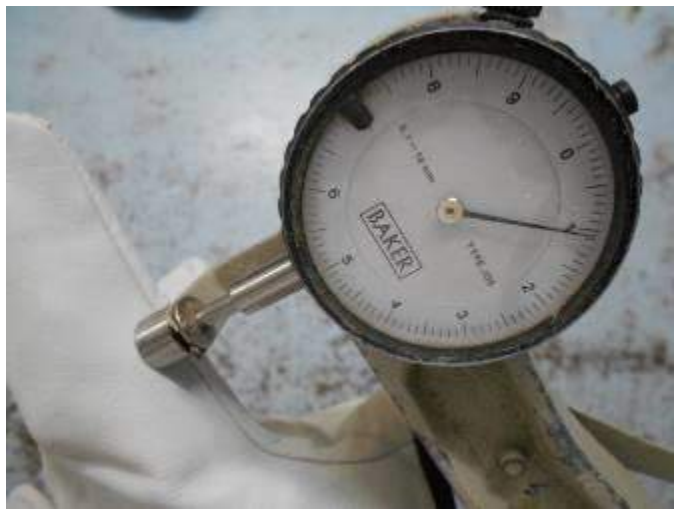
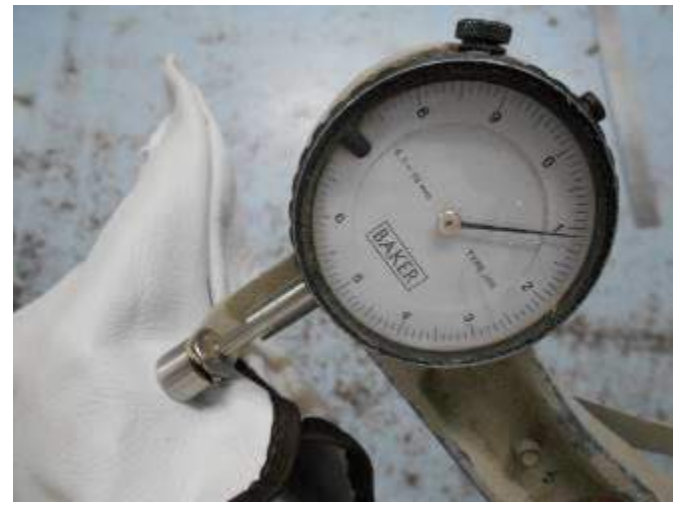
<p>Test the thickness of the item- (13 Pairs)</p>	<p>Checked & found satisfactory against clients given instruction.</p>	<p>Passed</p>
--	--	----------------------

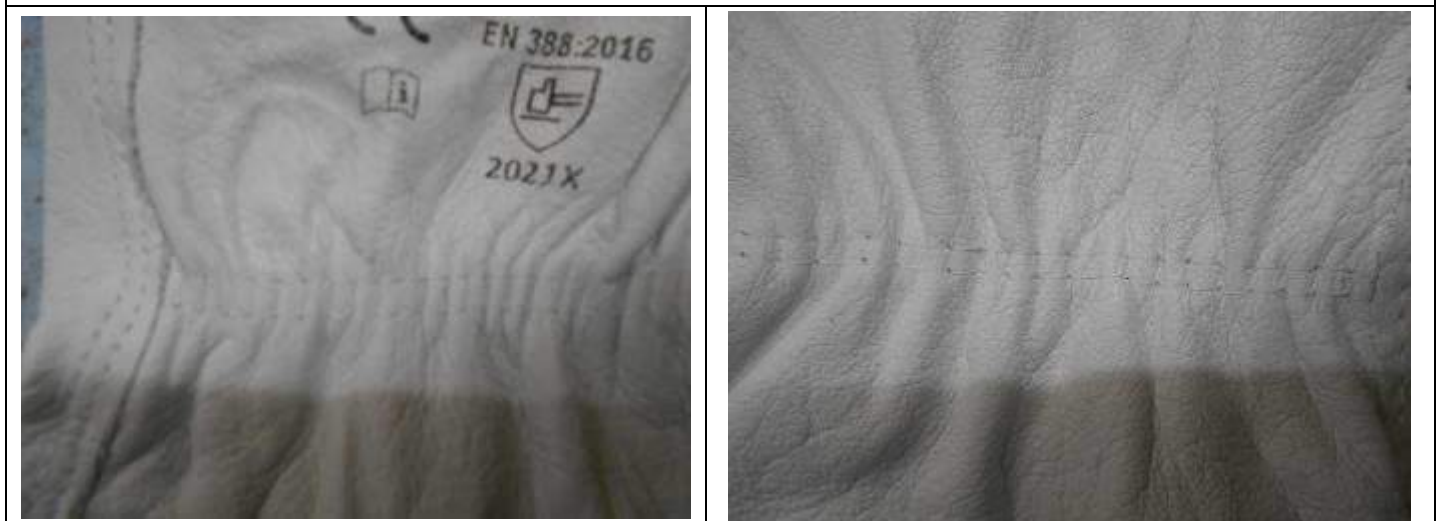
<p>Check the zigzag stitch finishing is properly done- all sample size.</p>	<p>Checked & found satisfactory.</p>	<p>Passed</p>
--	--	----------------------

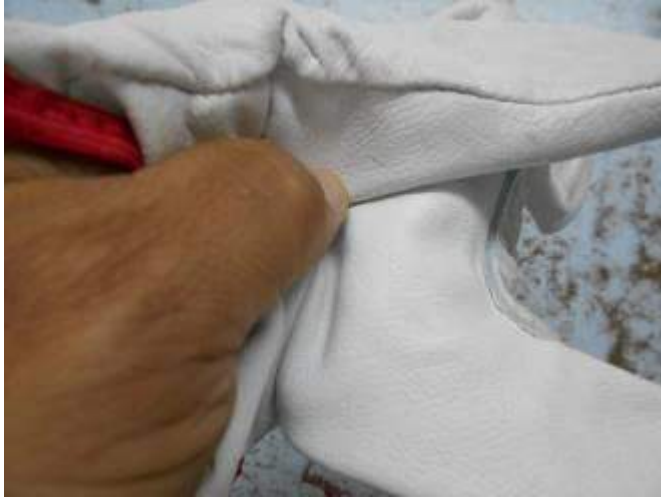
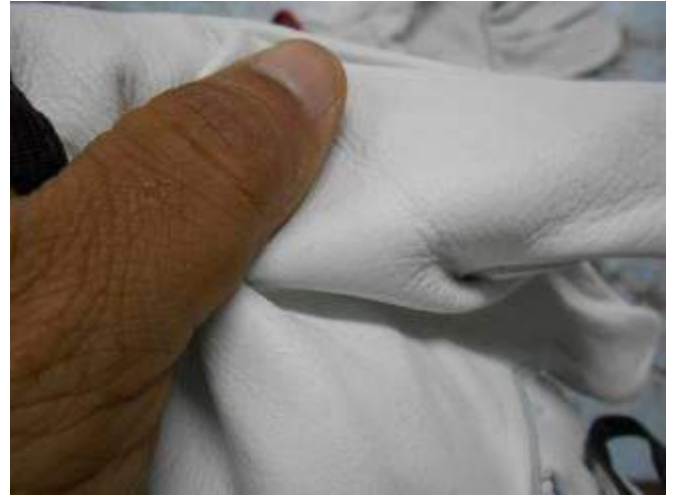
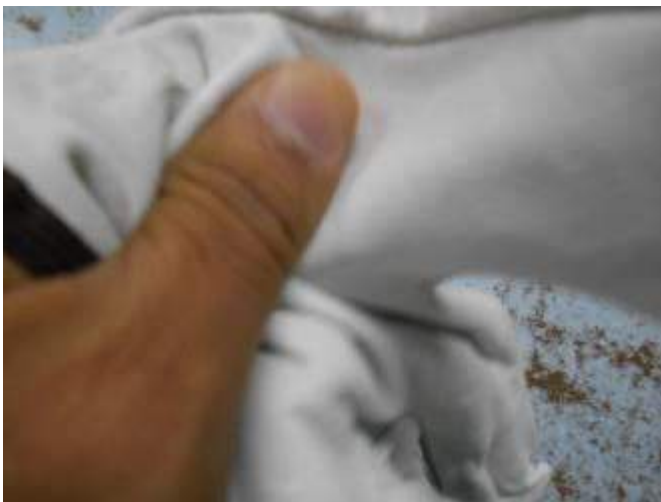
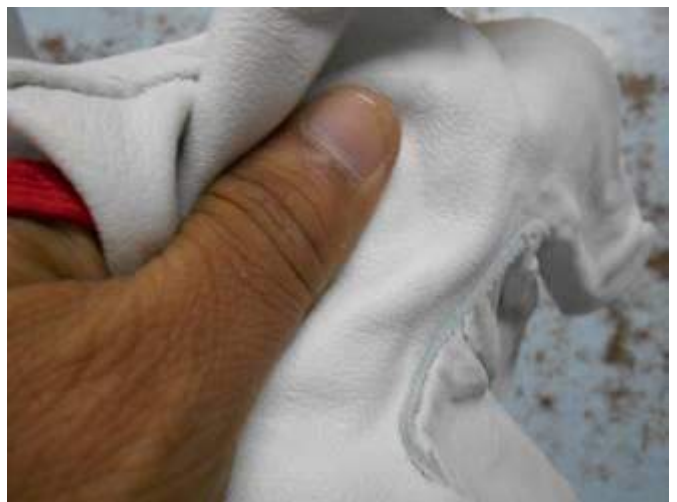
<p>Check the hand feel of the leather which should be soft enough—all inspected pairs.</p>	<p>Checked & found satisfactory.</p>	<p>Passed</p>
---	--	----------------------

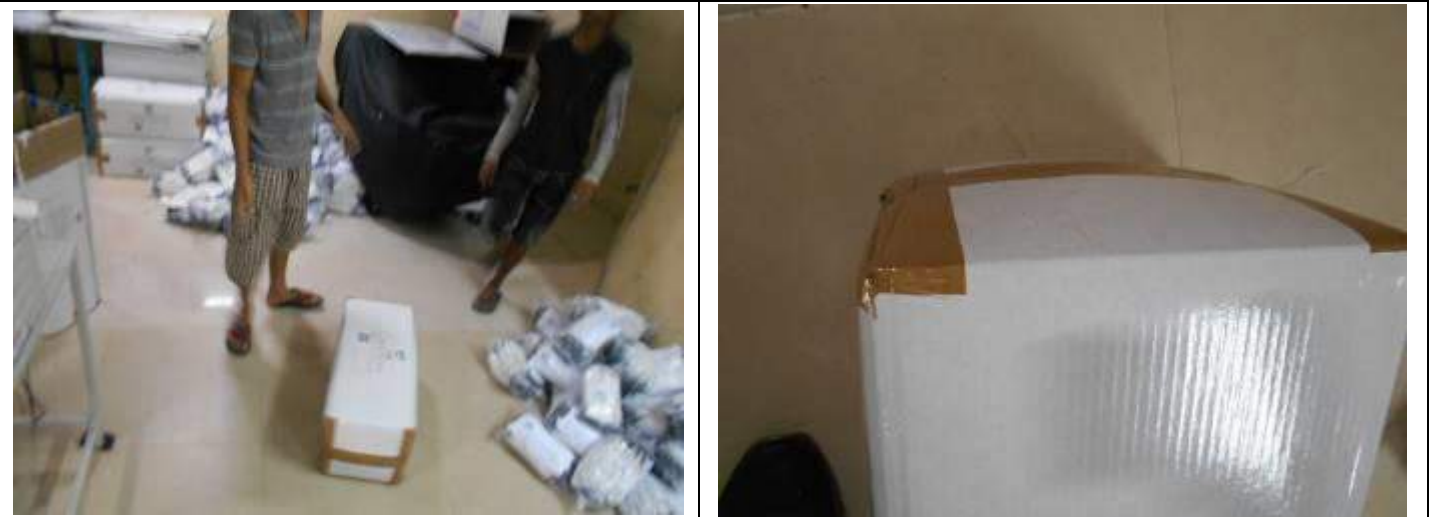
<p>Perform a carton drop test on the export cartons: checked with 2 packed carton dropped from a minimum loading & unloading distance to check the durability of the carton & product safety after the drop.</p>	<p>Checked & found satisfactory.</p>	<p>Passed</p>
---	--	----------------------

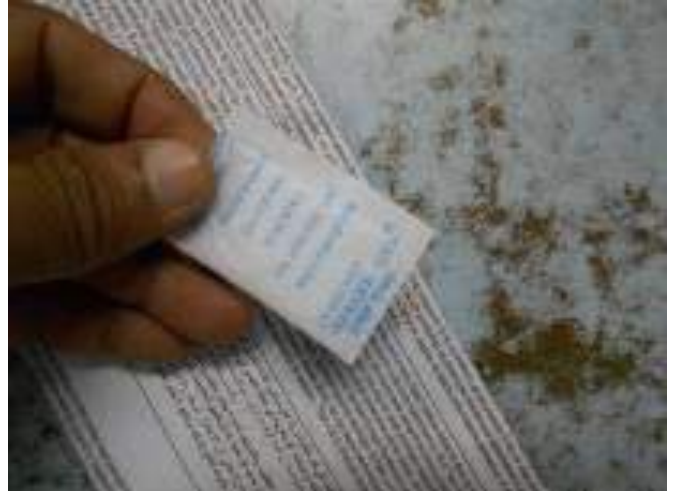
USED SILICA GEL INSIDE THE POLY BAG

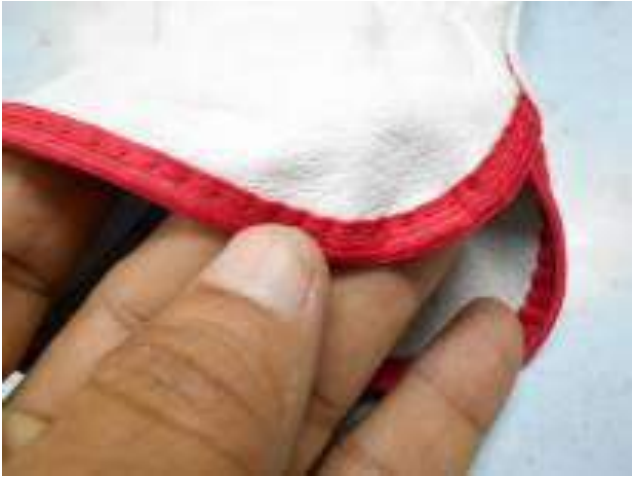
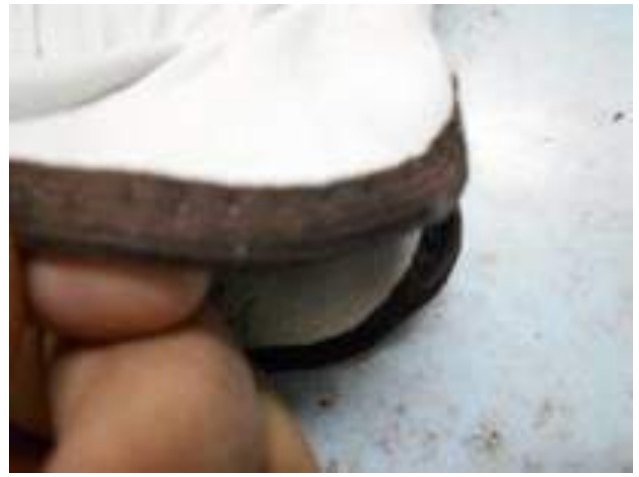
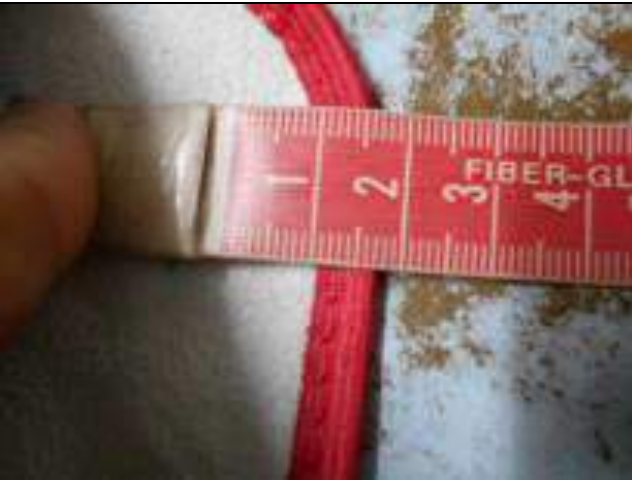
0.7 MM CUFF TAPE FOR #2241

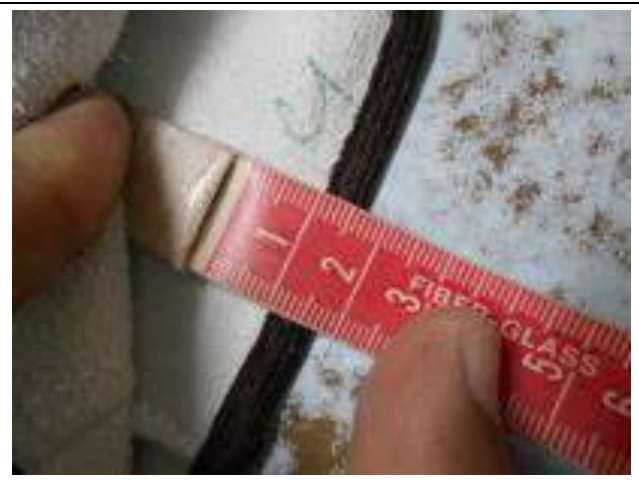
0.7 MM CUFF TAPE FOR #2220

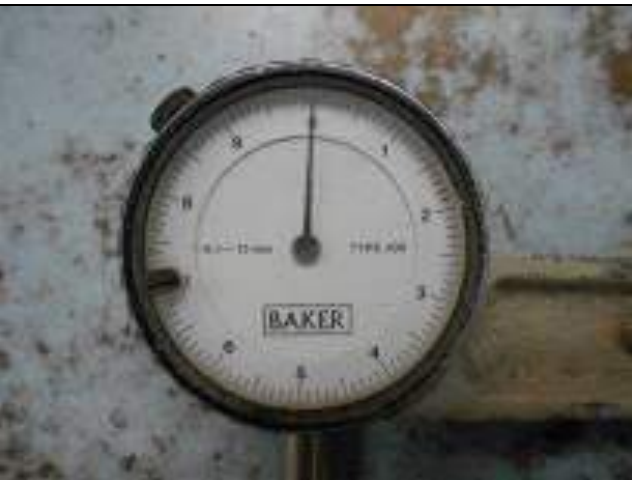
THICKNESS METER ON NUTRAL MODE

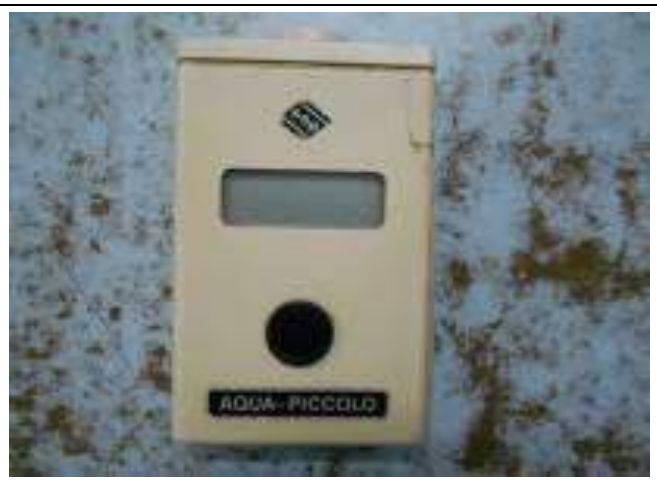
MOISTURE METER ON NUTRAL MODE
